THREE MEADOWS RESTORATION

EXISTING CONDITIONS ASSESSMENT AND RESTORATION ALTERNATIVES - DRAFT

Amanda Watson, Amador Resource Conservation District

January 14, 2019

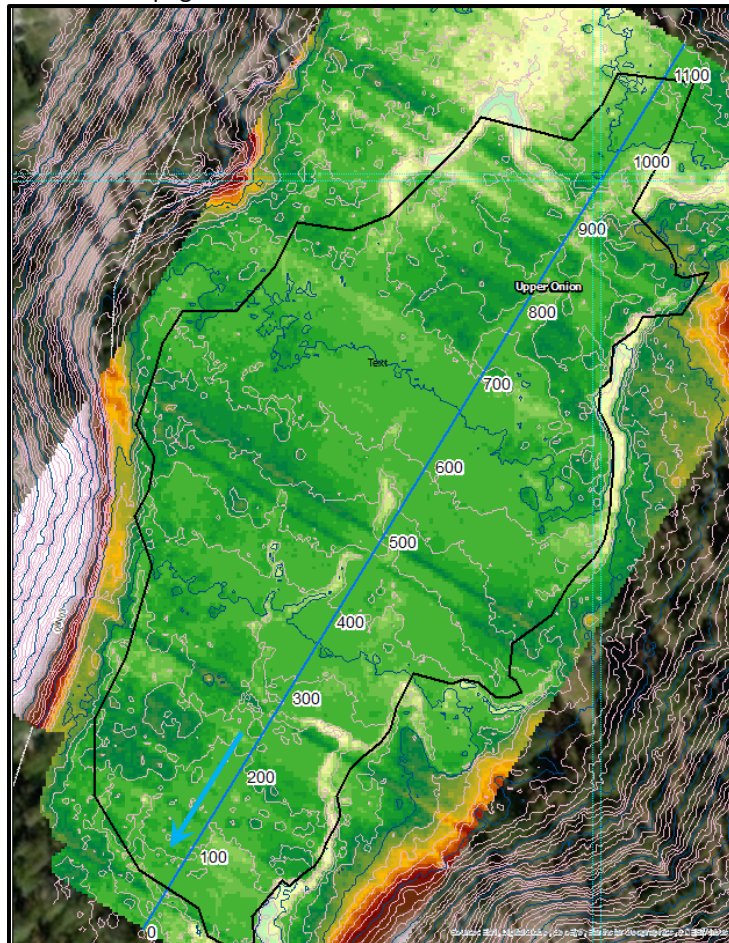
The REM was only generated for Upper Onion Meadow because it was determined to be an historically depositional environment and has experienced cumulative impacts that have caused it to cross a threshold from depositional to erosional. Determining the specific forcers and a timeline of events that led to the initial perturbation and degradation is difficult, if not impossible. It is likely a combination of factors such as heavy, prolonged grazing, followed by modifications to the hydrology. As mentioned previously, slight changes in the independent physical variables can lead to significant changes in meadow condition. For example, there is evidence that the Upper Onion site has not always been a

meadow. During the site visit we observed stumps that had been exhumed due to channel incision. This observation mirrors what was documented by Wood (1975) in incised meadows channels throughout the Sierra Nevada. Wood conducted detailed stratigraphic analysis of these meadows using carbon dating and other methods and came to the conclusion that many of these meadows were forested up until approximately 1,200 year before present (ybp). Climatic variation, initiated by a neoglaciation event from approximately 2800 ybp and 1200 ybp, led to loss of forest cover and a rise in the water table in depositional basins. Continued late season snow pack has maintained these conditions to the present date. This has implications for climate change associated with the rise of atmospheric CO².

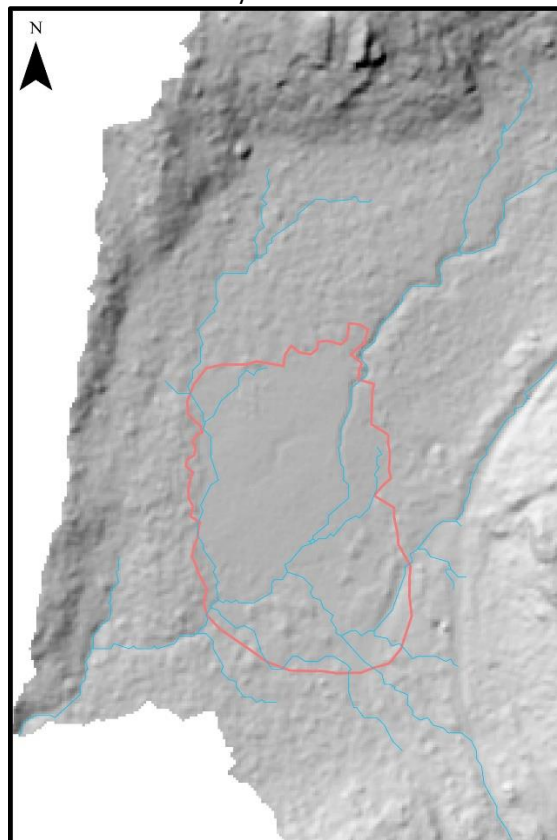
Figure 6: Shaded relief map of Tyler Meadow using LiDAR data. The blue lines represent LiDAR derived stream channels based on a cell-based analysis of flow area and direction.

watershed has not led to incision of the meadow. There are signs that grazing impacts have significantly impacted the ecological value of the meadow and access to the meadow from OHV's have caused localized impacts, but in general it does not appear there have been water table impacts that directly relate to channel incision.

The primary issue at Tyler is the condition of the channel upstream of the meadow, whether or not that area was historically part of the meadow, and what the benefits would be of attempting to aggrade the channel. The apparent age of the trees upstream of Tyler Meadow suggests that it has been forested for quite some time. The drainage area at the outlet of Tyler was calculated to be 0.1 square mile. A closer look at the topography of the watershed that drains to Tyler suggests that the actual drainage contribution to the upper end of the meadow may be less than half of that (Figure 6). Two other drainages enter the meadow downstream of the primary drainage, which may have a significant influence on groundwater depths longitudinally along the meadow and up into the forested portion of the Tyler drainage.

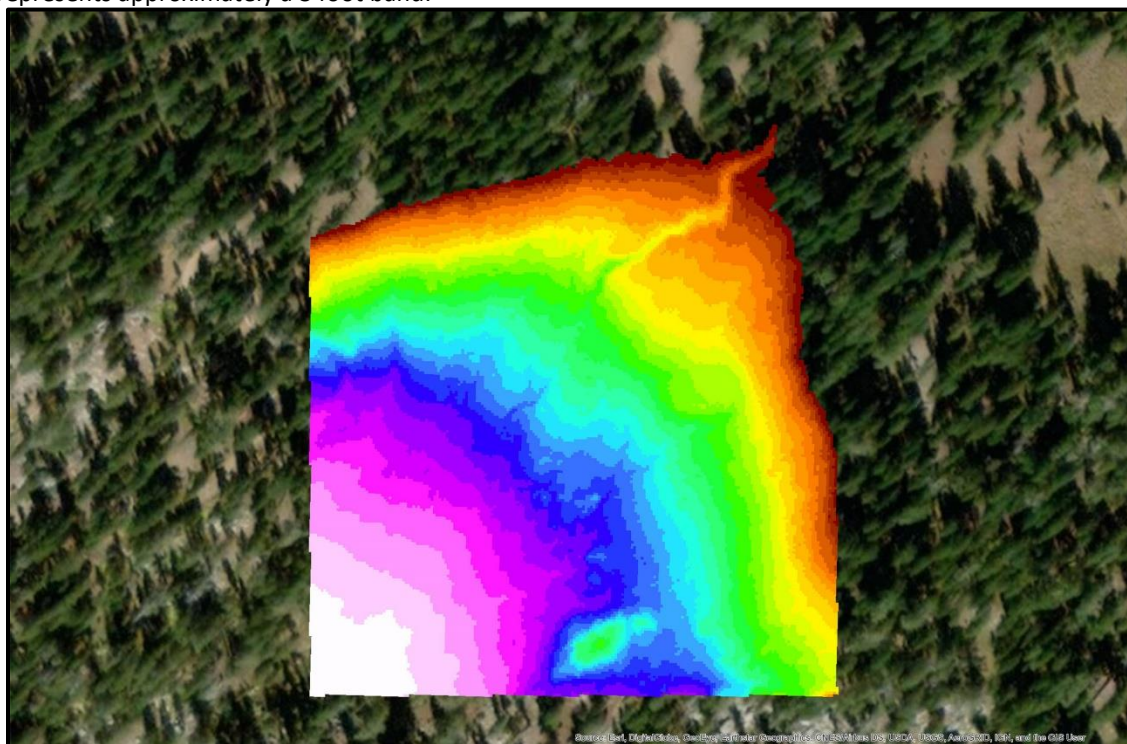
Figure 7: Color ramp elevation map of High Onion and adjacent areas from LiDAR. Each color band represents approximately a 3 foot band.

A landscape analysis of High Onion Meadow suggests that it is a much different meadow, morphologically, than Upper Onion and Tyler (Figure 7). The high groundwater table appears to be driven by subsurface flow from colluvial material from adjacent hillslopes and alluvial fans that intersect at this location in the landscape, forcing water to the surface. Upper Onion appears to be one piece of a mosaic of “forest-free” areas in this headwater region of the Onion Creek drainage (Figure 8). It is one of the larger tree free areas and is bisected by the primary channel of Onion Creek, which has incised into the intersecting depositional areas. The overall slope of the meadow exceeds 5% though the stepped nature of the intersecting fans results in some portions of the meadow being flatter than 5% and some portions being much steeper. Slight incision of the primary channel appears to be the result of grazing and increased peak flow associated with the adjacent road network.

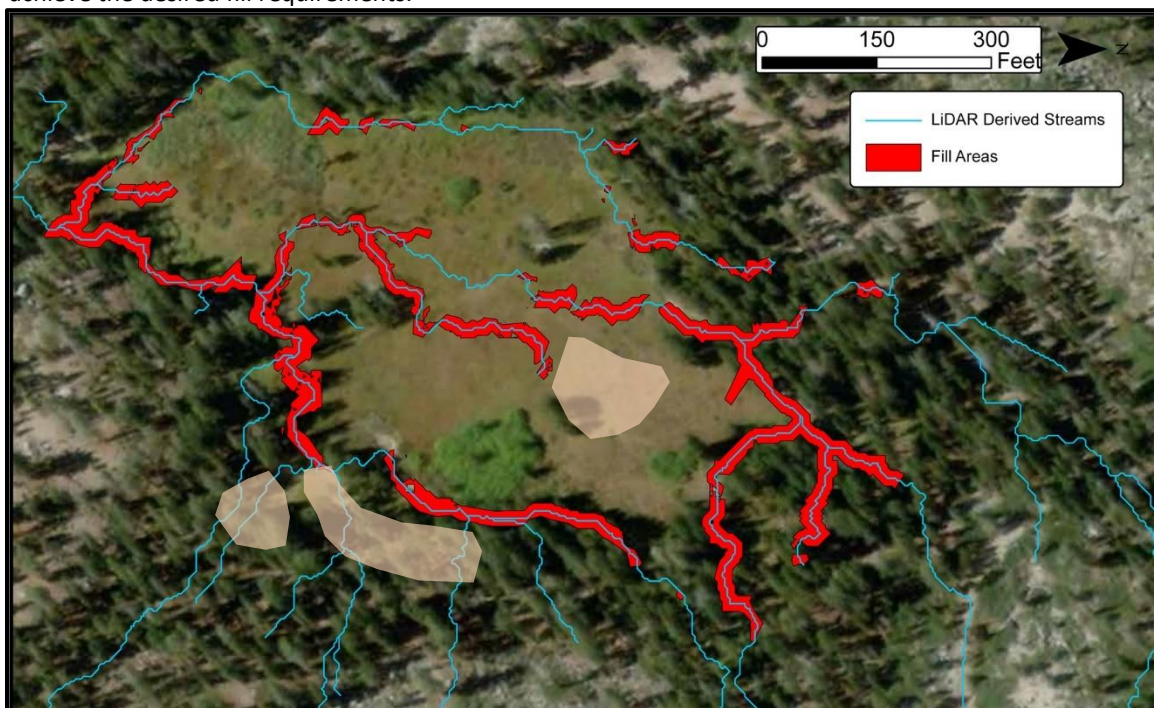
As discussed in this report, Upper Onion Meadow is the most degraded of the three meadows within the project area as evidenced by significant channel incision. Large patches of willow do still exist throughout the meadow along with other native wet meadow patches that appear to be in moderate to

- Alternative 2:** Alternative 2 represents the Stage 0 restoration condition. To restore the meadow to its historic condition all of the significant, continuous channels would be filled to a depth equal to the adjacent meadow. Periodically, higher berms in the filled channels would be constructed to ensure that the filled channel is not captured and reincised. Figure 9 provides a preliminary representation of where channels will be filled. This graphic is based on the REM map of Upper Onion Meadow that was discussed previously (Figure 5). To ensure that a headcut does not originate from downstream and reincise the meadow, this alternative will also incorporate a roughened channel at the moraine. Preliminary estimates suggest that a total of 2,200 cubic yards of fill would be required for Alternative 2 in addition to approximately 115 cubic yards of imported material for the roughened channel at the downstream end.

- Alternative 3:** Alternative three consists of a hybrid between Alternative 1 and Alternative 2. The primary channels that are highly incised would receive the constructed riffle treatment discussed in Alternative 1. The remaining, smaller and/or discontinuous channels would be filled using the approach described for Alternative 2. An overview of where each treatment would occur is shown on Sheet C3 of Appendix B. Profiles where constructed riffles would occur are the lower portion of Profile 1, the lower portion of Profile 2, and most of Profiles 7 and 8. A roughened channel would be constructed at the downstream end of the project, as described in both Alternative 1 and 2. This alternative is expected to require 115 yards of imported material for the roughened channel, 700 yards of fill for the Stage 0 channels, and approximately 500 cubic yards of fill for the constructed riffles.
