BAGLEY FIRE

EROSION AND SEDIMENTATION INVESTIGATION

INTERIM REPORT

SHASTA TRINITY NATIONAL RECREATION AREA, MOUNTAIN GATE, CA

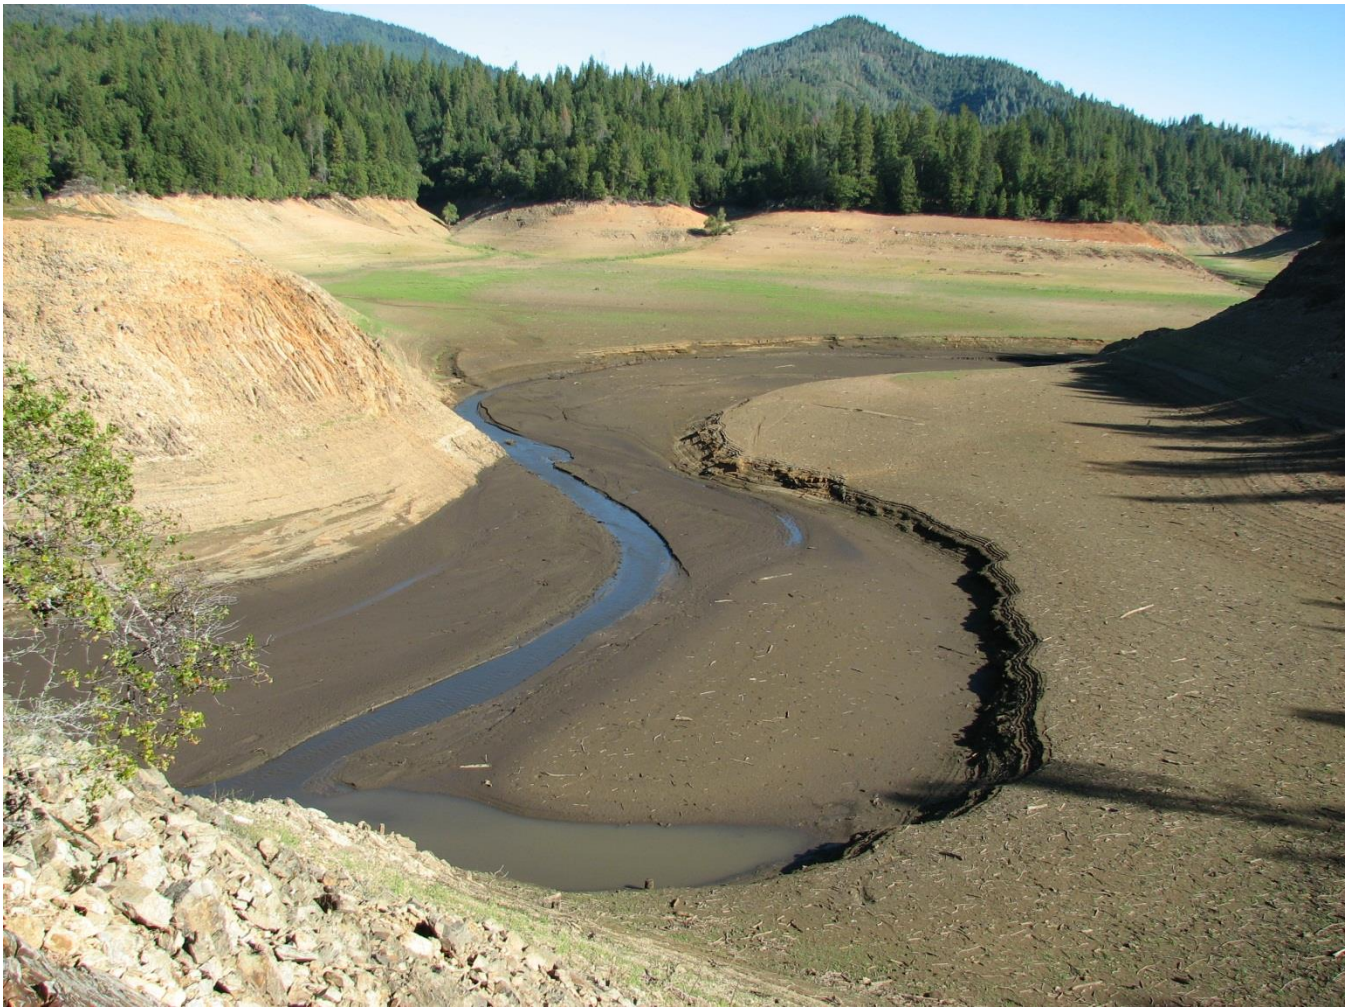
Photo 1 (#7462) New sediments in the Squaw Creek Arm Shasta Lake SW of Madison Gulch; 9-26-13 JdIF

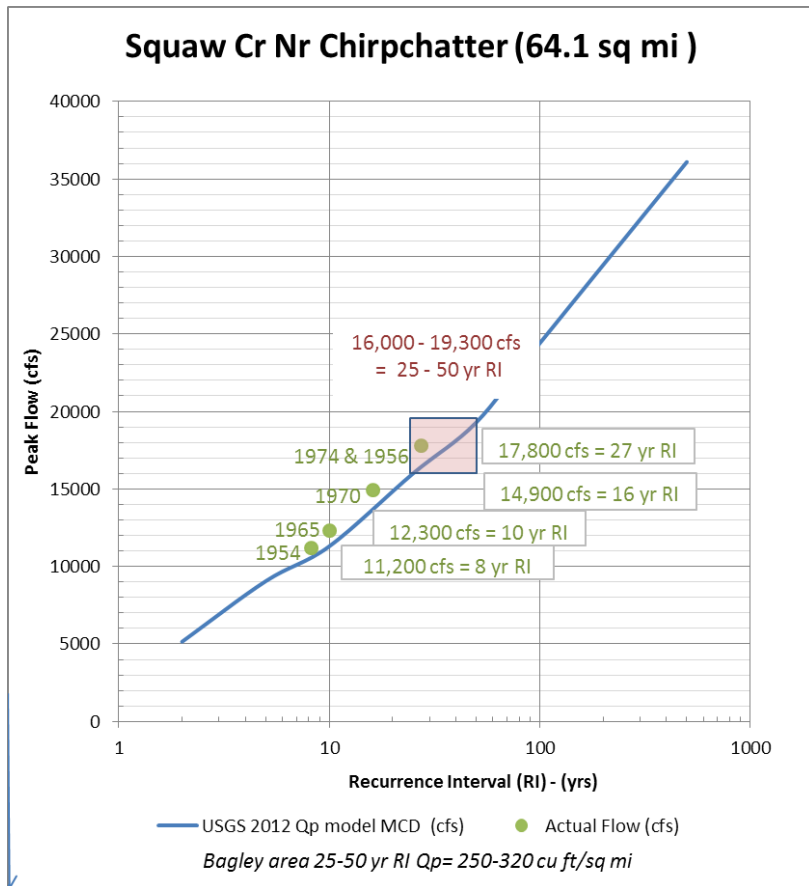
Figure 6 - Measured and modeled stream peak flows from the Squaw Creek US Geological Survey stream gauge site near Chirpchatter (now inactive). Note that there is some uncertainty about the data point for 2007 (under review). The model predicts discharge at Chirpchatter in excess of 15,000 cfs for the 25-year flow event. Repeat channel survey (SCI) reaches were located significantly upstream of Chirpchatter.

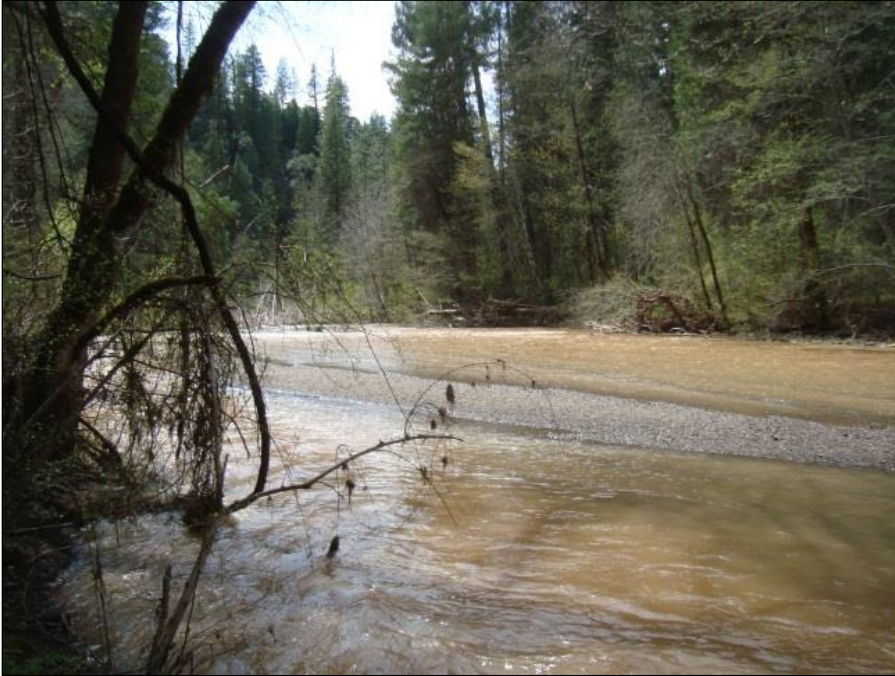
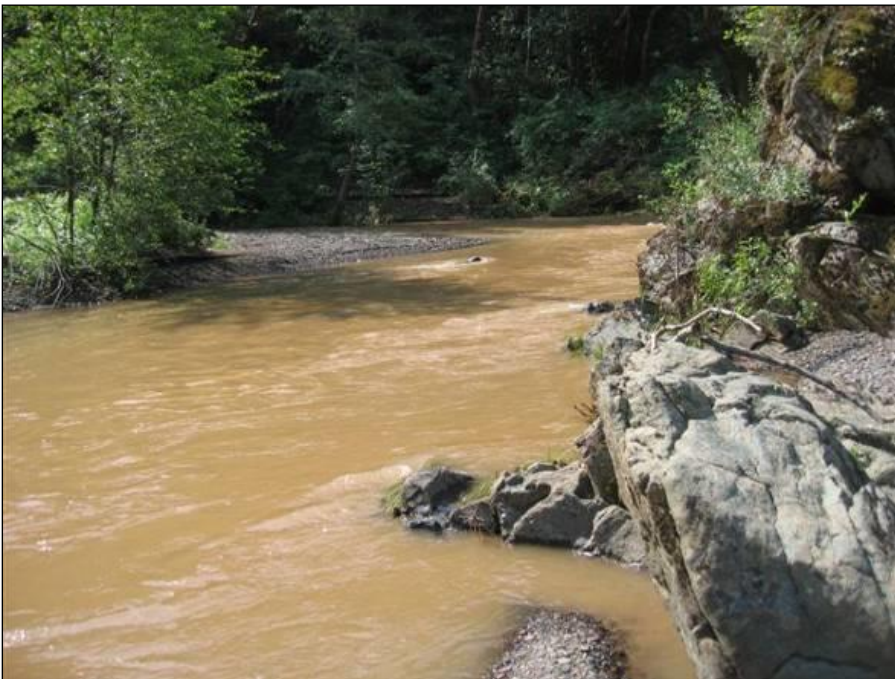
Photo 2a (top) and 2b (bottom) - Squaw Creek Turbidity and Deposition (Photo 2a taken in April, 2013, and 2b in July, 2013)

Squaw Creek displayed high turbidity levels on April 11th and July 1st 2013. Elevated streamflow and turbidity levels persisted for months following the 2012 storms. Turbidity in Squaw Creek gradually diminished in late-Spring but rose sharply in late-June in response to summer precipitation. Water temperature data acquired before and after the fire have not yet been analyzed, but will be addressed in the final report.

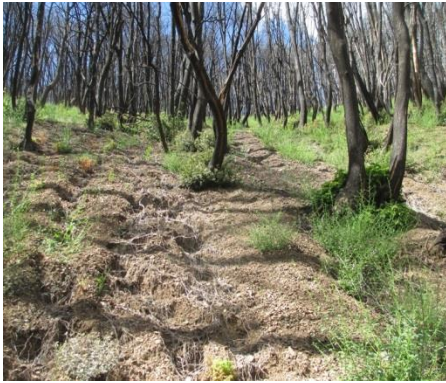
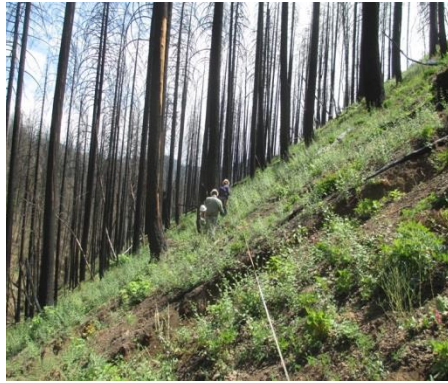
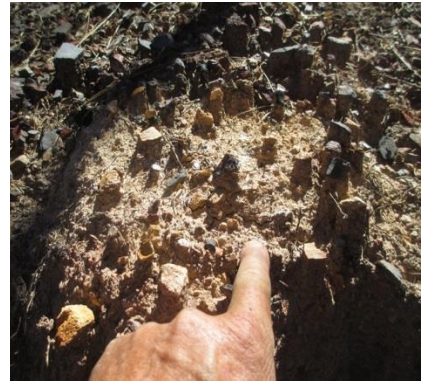
Photo 4a (left) 4b (center) and 4c (right) - August, 2013 by Brad Rust

Typical deep riling in severely burned landscape on south-facing slopes

Steep landscapes with long slopes lengths had deep rills and gullies

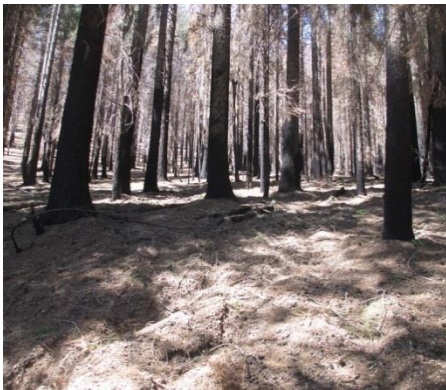
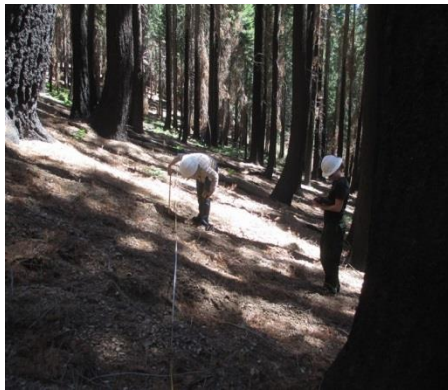
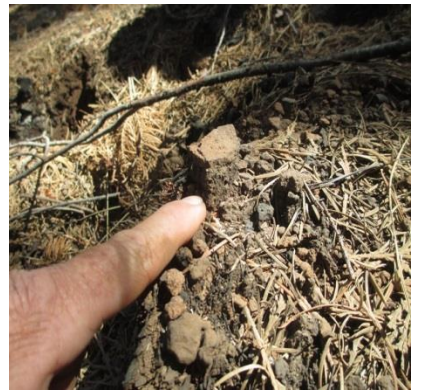
Photo 5a (left) 5b (center) and 5c (right) - August, 2013 by Brad Rust

Typical deep riling in medium burned landscape on east-facing slopes.

Transect data collection measuring depth and width of riling.

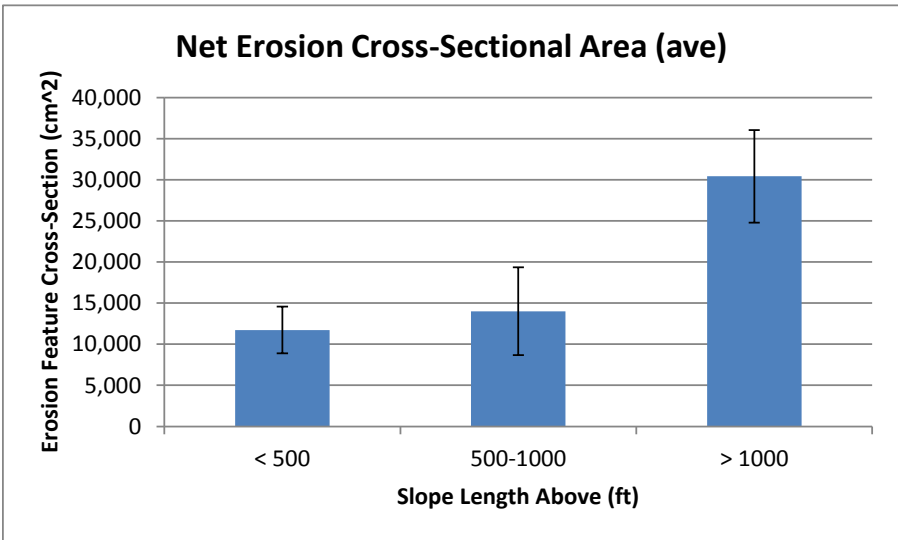
Figure 8 - Erosion Area by Slope Length

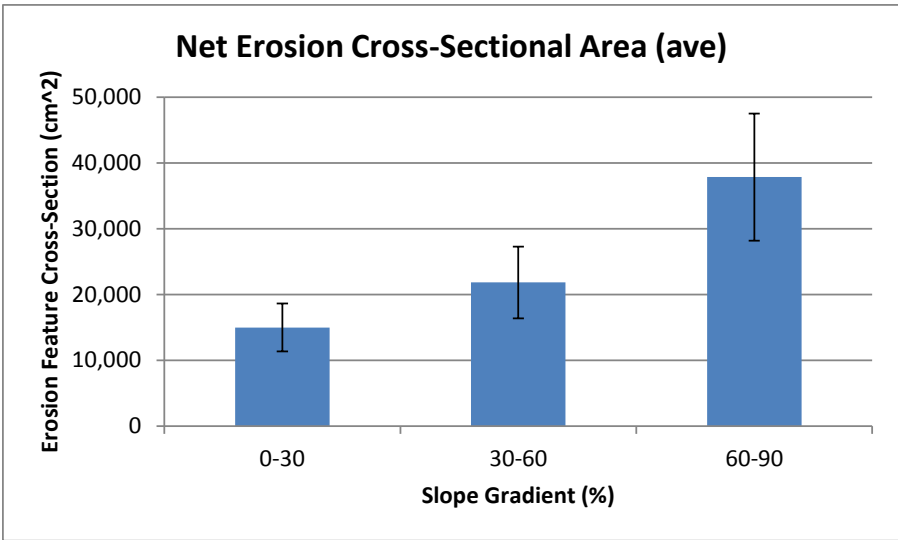
Figure 9 - Erosion Area by Gradient

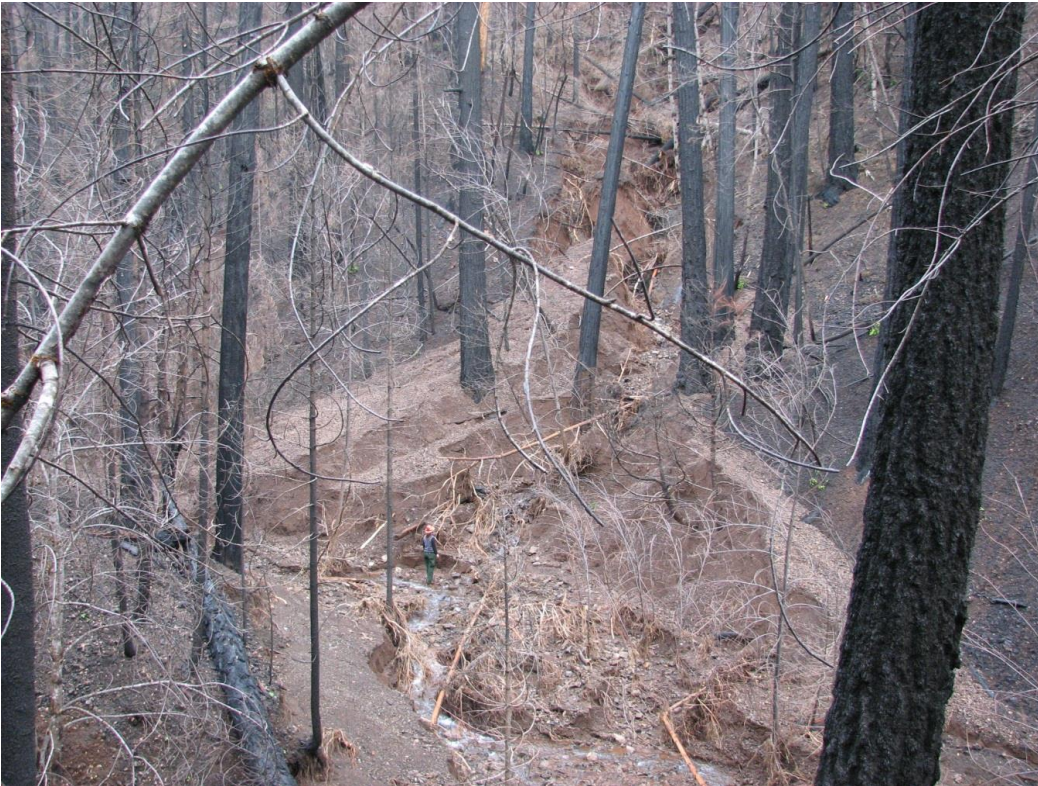
Photo 6 (#8736) - Fresh debris fan in tributary to Iron Canyon Creek 12-14-12 JdlF

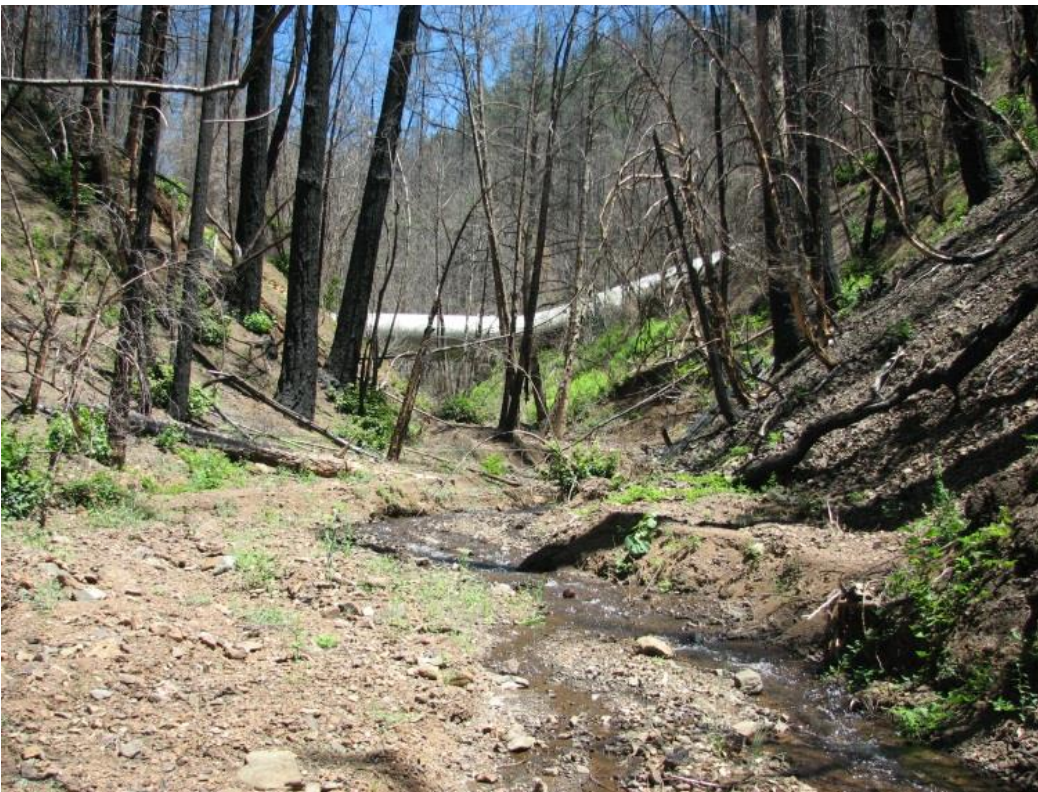
Photo 7 (#4240) - Tributary to Iron Canyon Creek below PG&E penstock (downstream from Photo 6) 6-12-13 JdlF

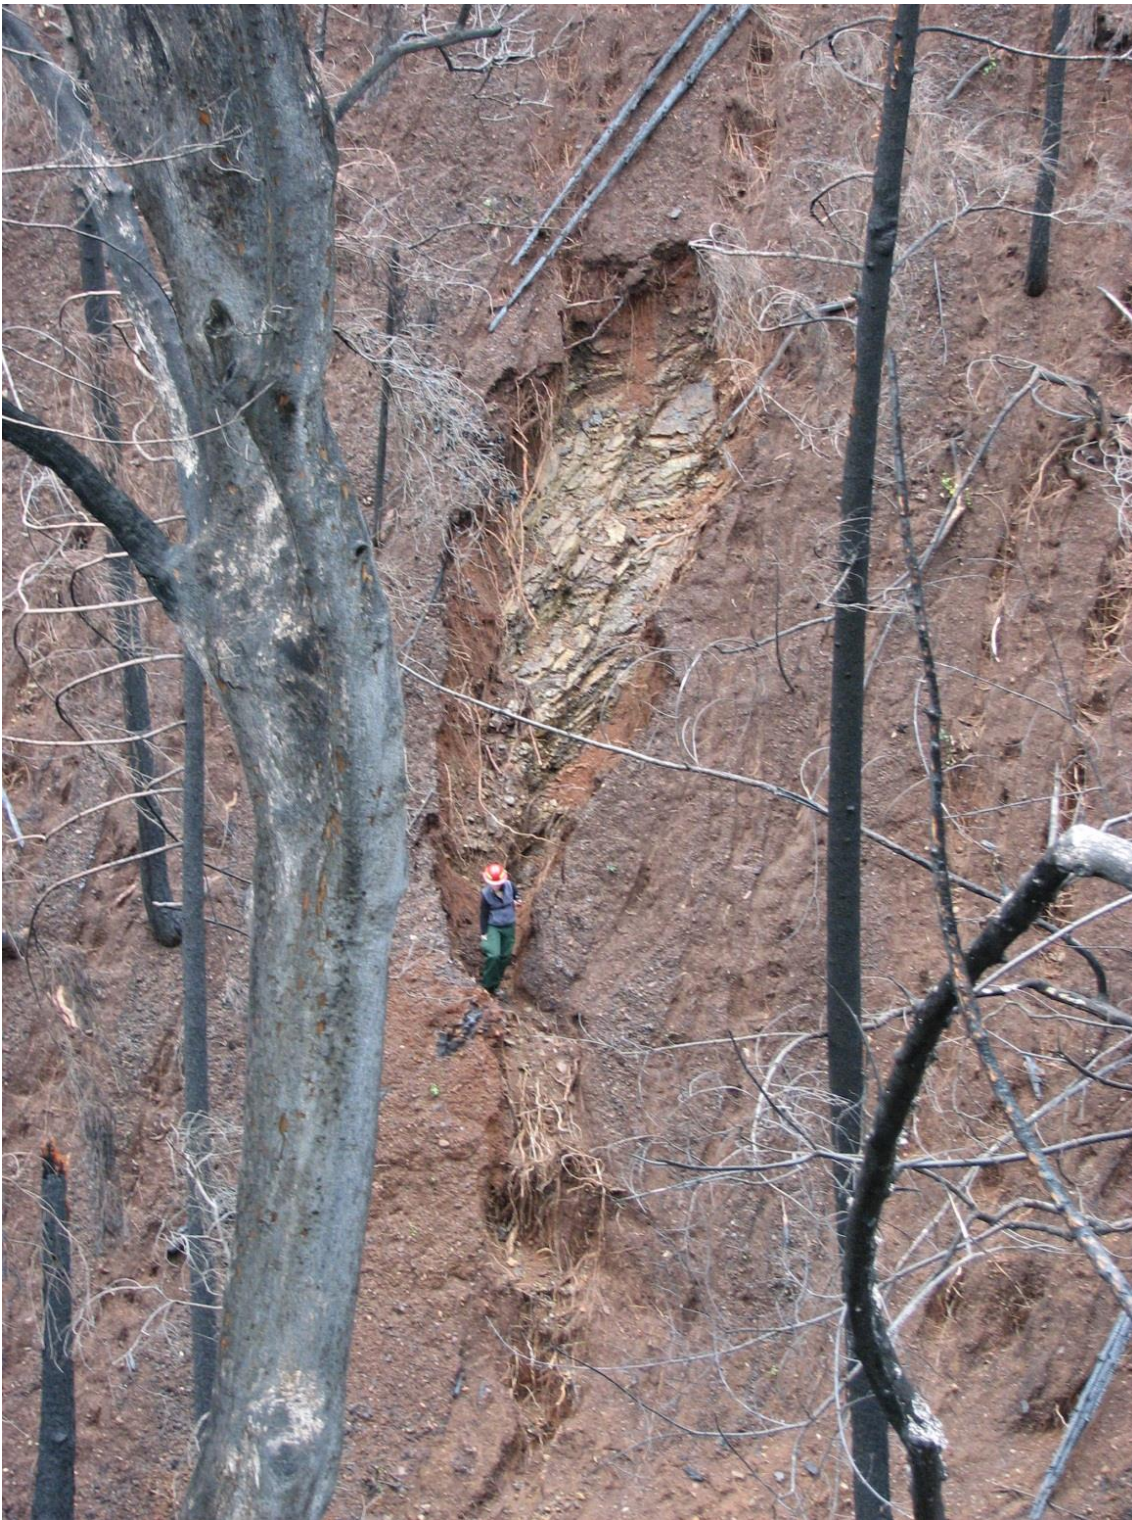
Photo 8 (#8647) - Shallow debris slide (about 5 ft. of colluvium on bedrock) in a tributary to Iron Canyon Creek 12-14-12 JdIF

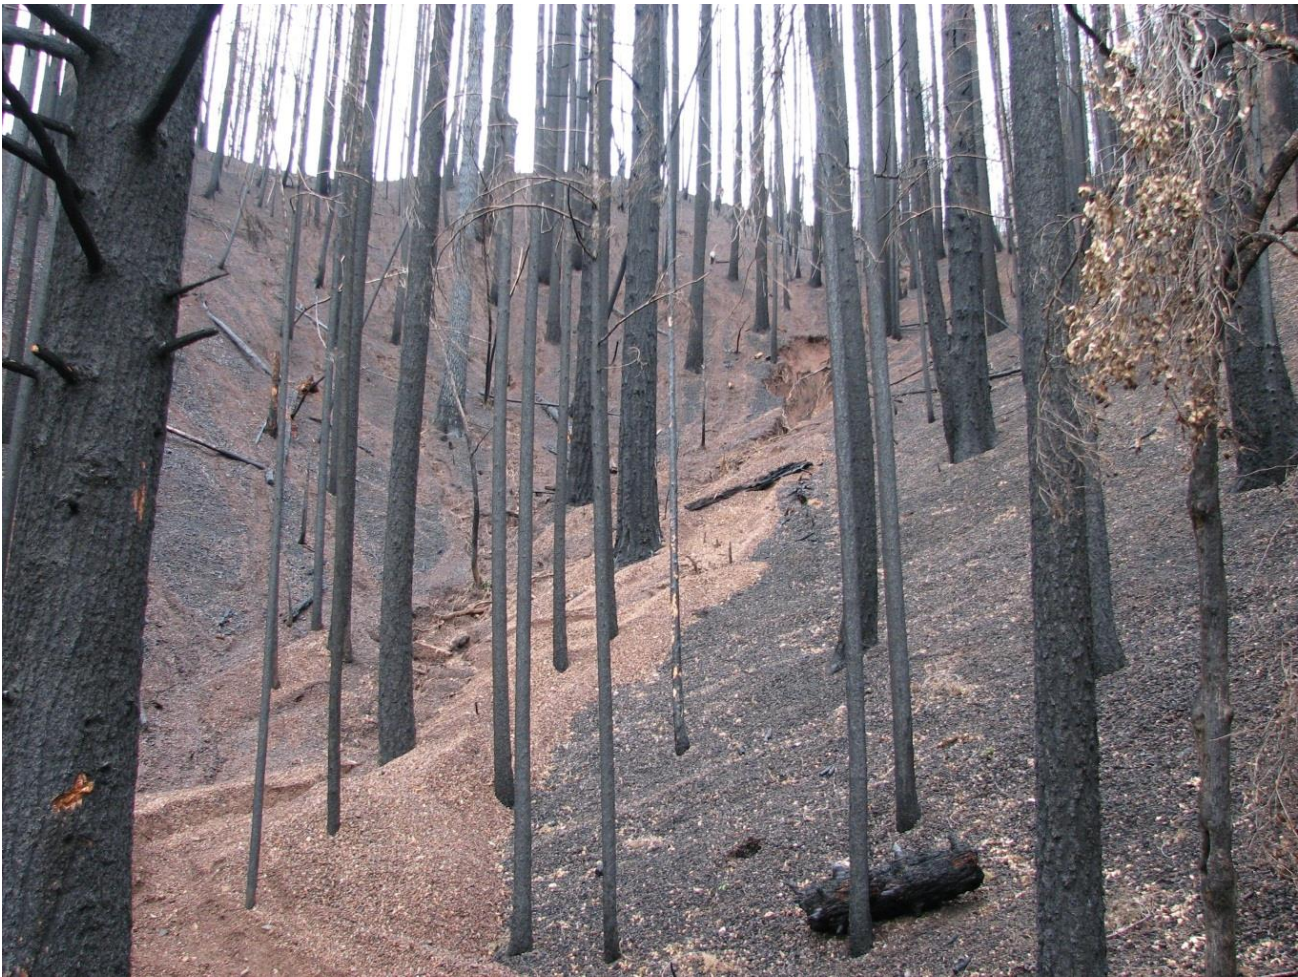
Photo 9 (#8508) - Gravel debris flow in a tributary to Iron Canyon Creek 12-14-12 JdIF

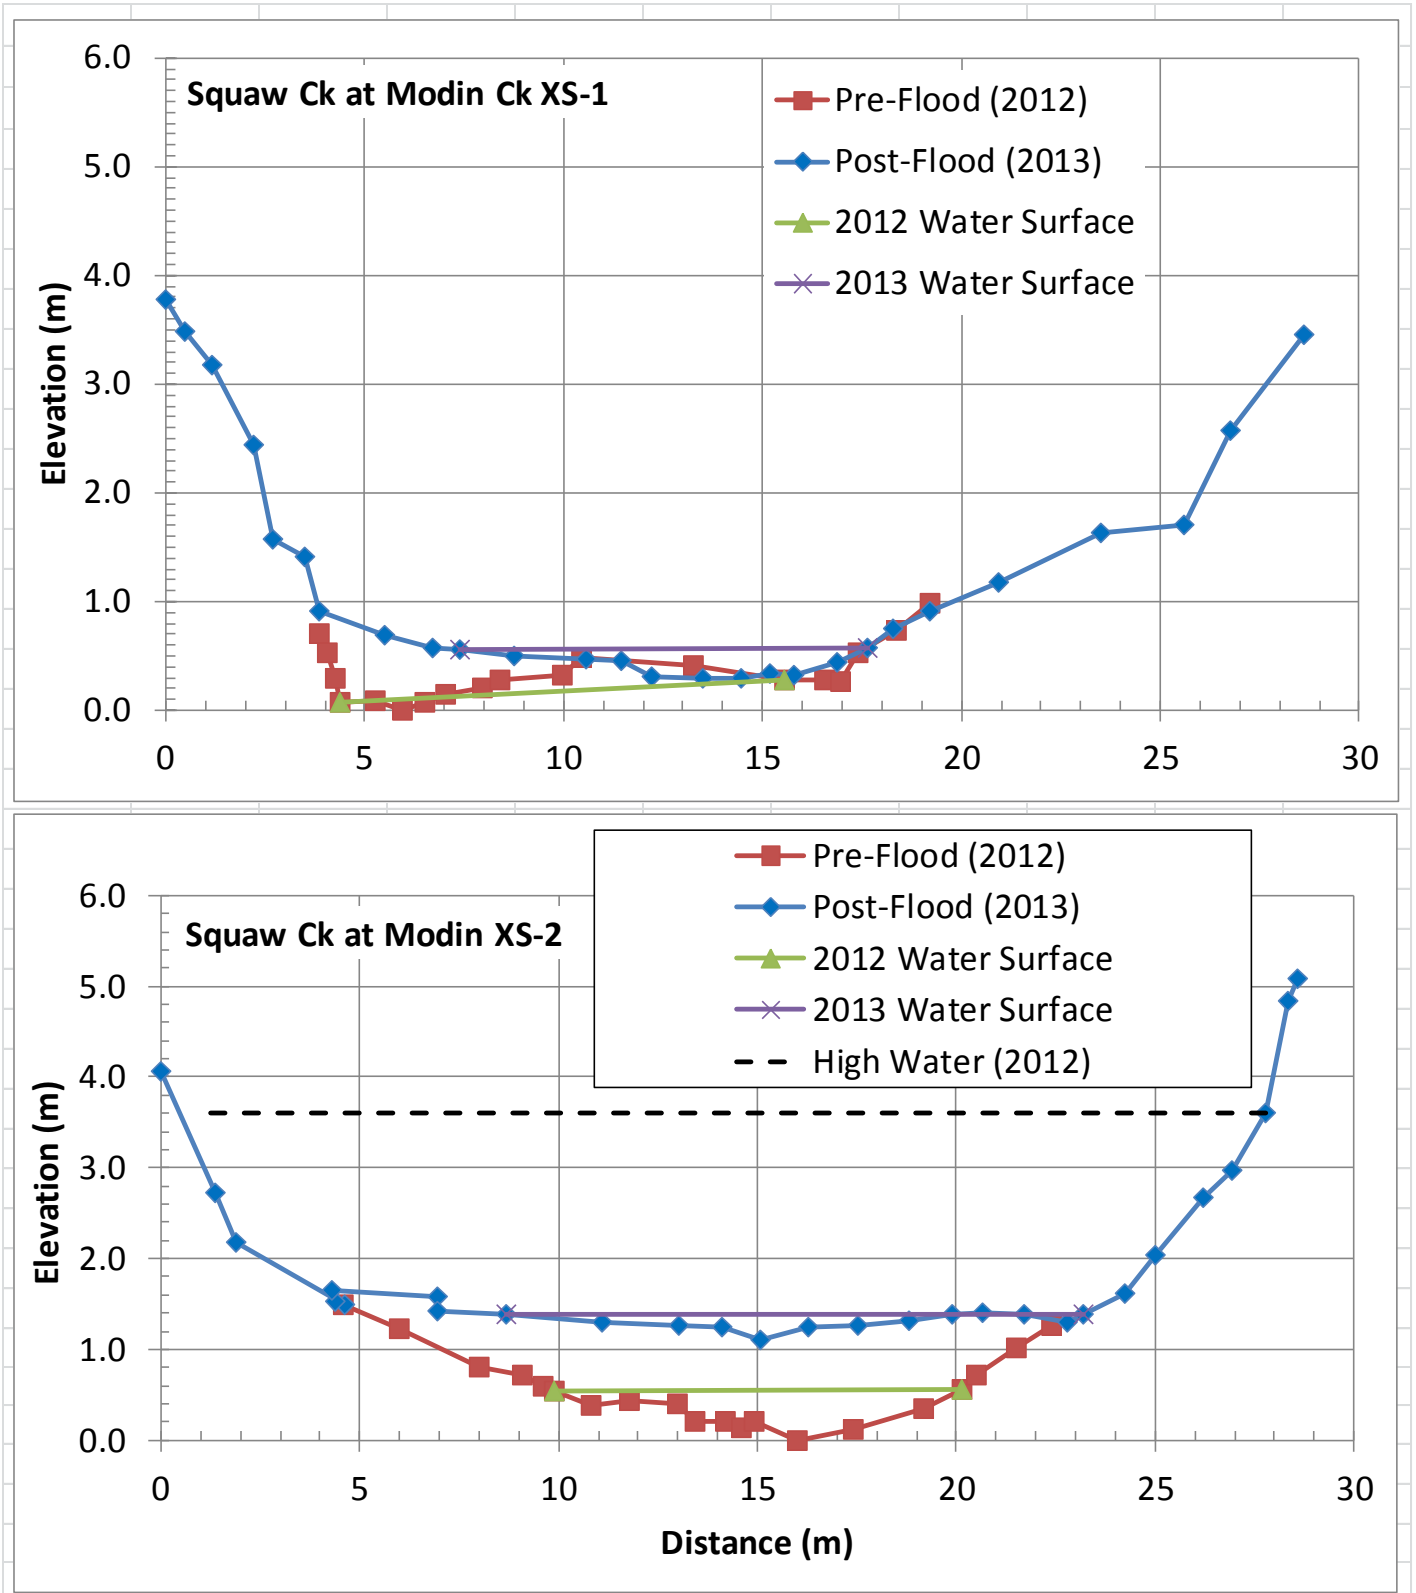
Figure 14 - Repeat channel X-section surveys from the Modin Creek reach of Squaw Creek. Repeat channel surveys were performed in August 2012 and July 2013 in three reaches of main stem Squaw Creek. These data when compared with one another documented channel change resulting from the 2012 flood. Data indicate an active channel width of 15 to 20 meters and channel filling of up to 1 meter by flood sediment. Horizontal and vertical scales are equal in both plots. 2012 X-section end pins were apparently set near the pre-flood bankfull elevation.

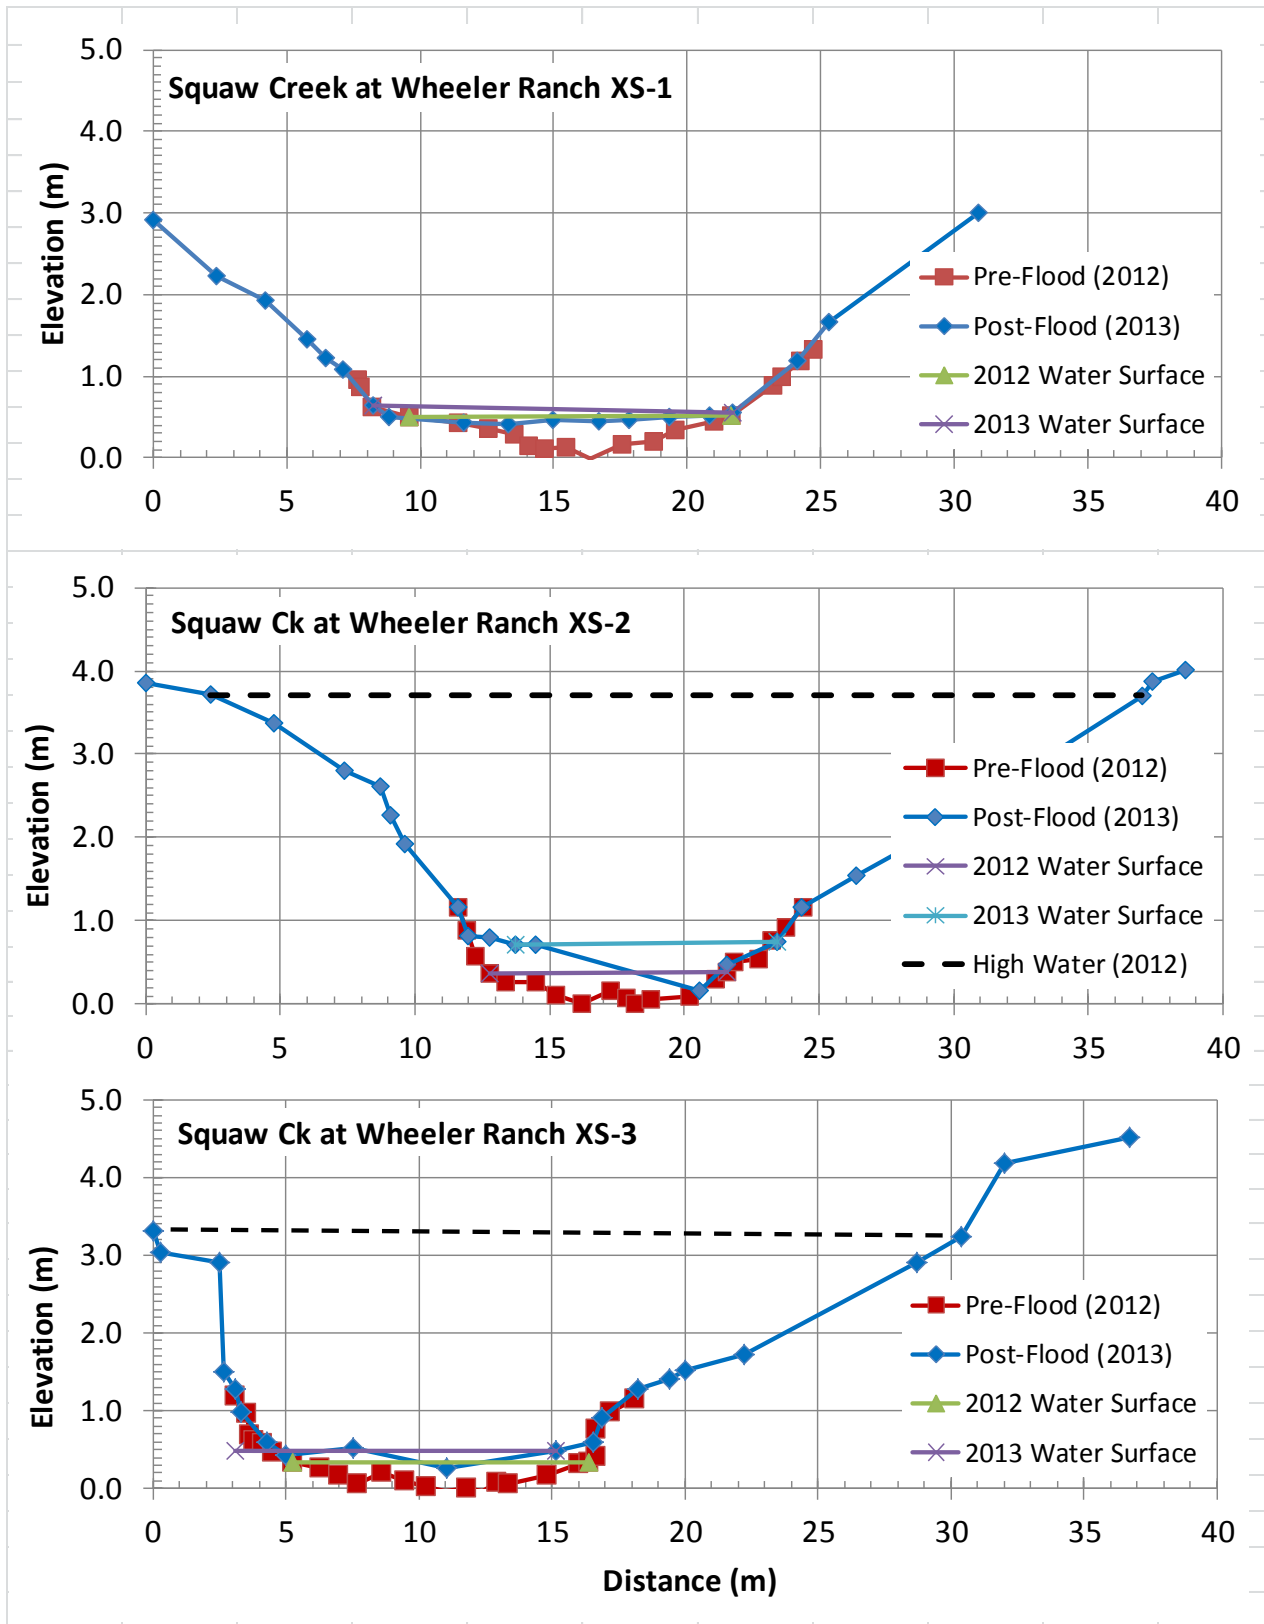
Figure 15 - Repeat channel X-section surveys from the Wheeler Ranch reach of Squaw Creek. Channel widths are similar to those in the Modin Creek reach but the channel bed only filled to a depth of approximately 0.5 meters. Black dashed lines denote surveyed high-water marks. 2012 cross section end pins were apparently set near the pre-flood bankfull elevation. Horizontal and vertical scales are equal in all plots.

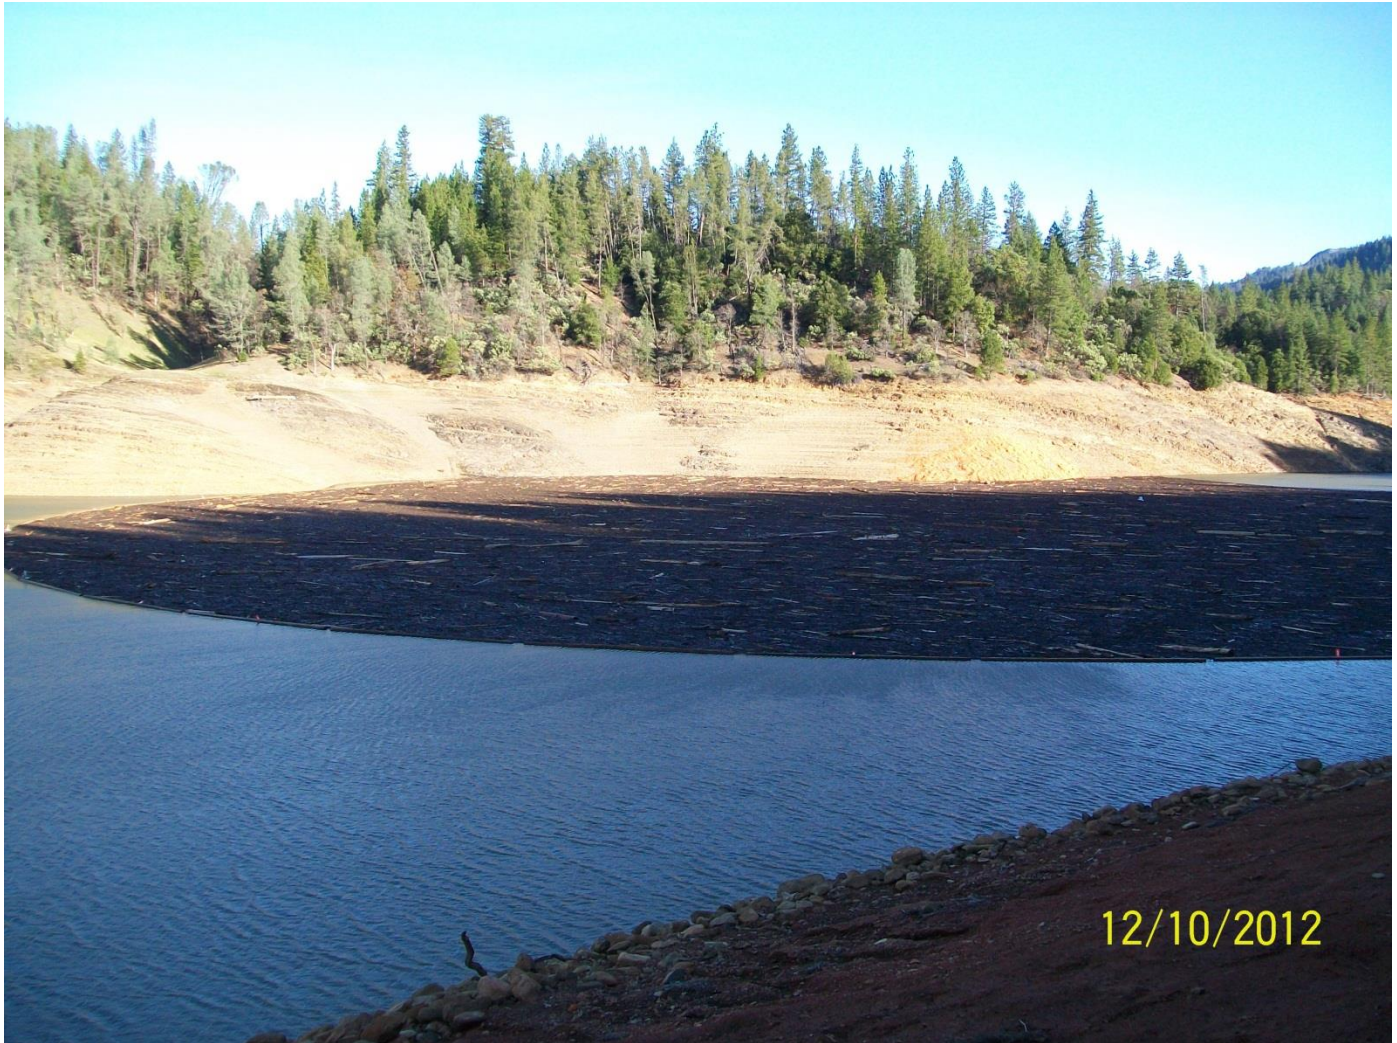
Photo 10: View upstream of the Squaw Creek arm of Shasta Lake and log boom system filled with flood debris.

The 2012 flood transported significant volumes of woody debris to Shasta Lake from both Squaw Creek and the McCloud River, and field personnel observed large volumes of floating woody debris in the lake (Photo 10). In-channel surveys and interpretation of 1:4,000 post-flood air photos indicated that minor large wood volume was stored along Squaw Creek after the 2012 flood.

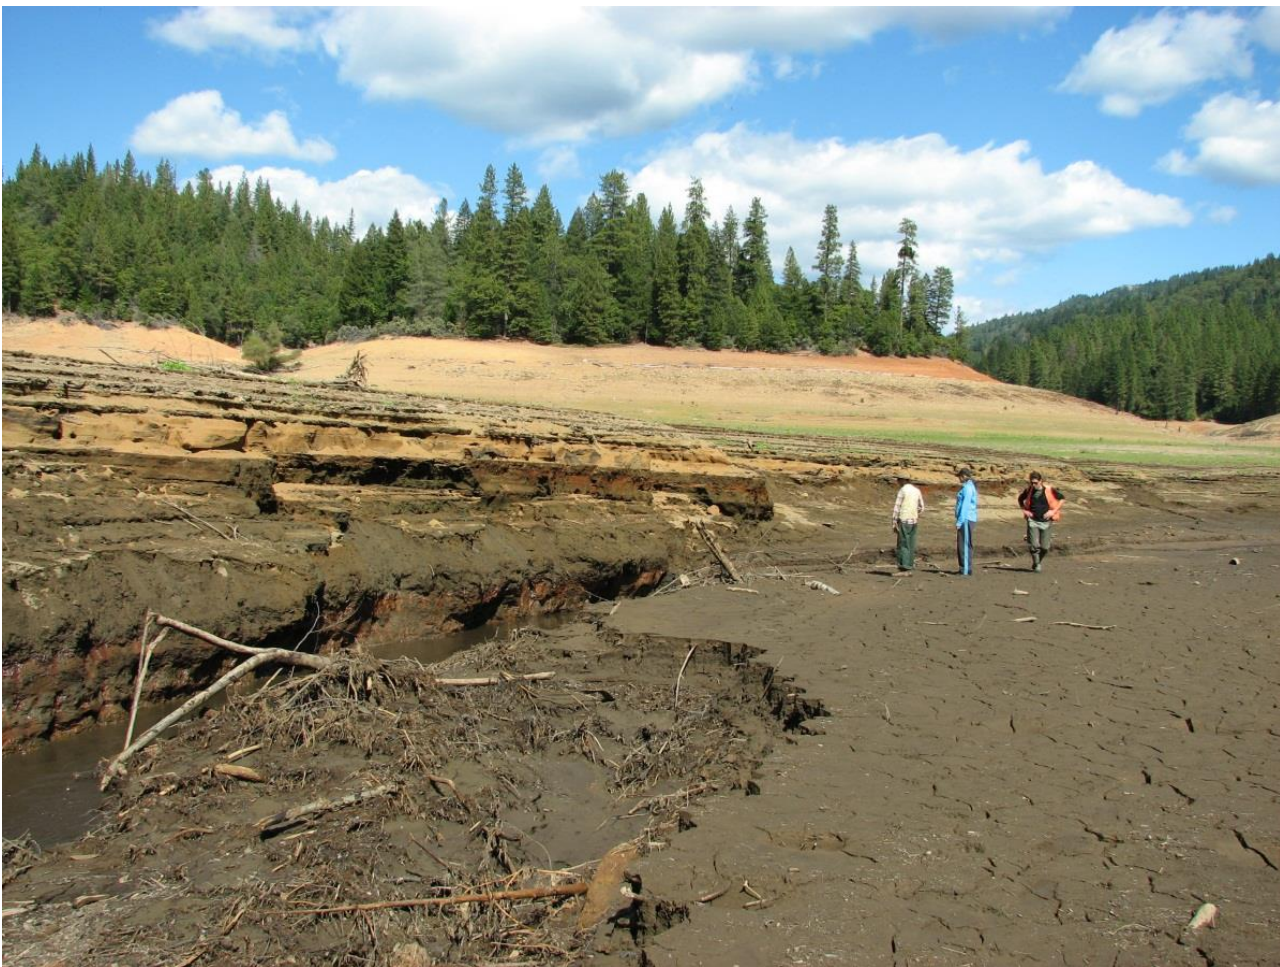
Photo 11 (#7542) - New sediments (foreground, dark brown) in the Squaw Creek Arm Shasta Lake SW of Madison Gulch 9-26-13 Jdlf

These sandy deposits were up to 10 feet thick near the mouth of Fowler Gulch. Dark brown silt which appeared to contain fine charcoal and organic material buried the flatter terrace areas, and in places, draped over the sands adjacent to the active channel. These deposits ranged from inches in thickness in the upper parts of the reservoir to 5 feet or more at lower elevations in flatter areas where they were less subject to wave erosion. Observations on 7-1-13, midway between the mouths of Fowler Gulch and Dark Canyon revealed that 2012 deposits were only 1 or 2 inches in thickness at an elevation of about 20 vertical feet above the reservoir level that day (1004 feet).

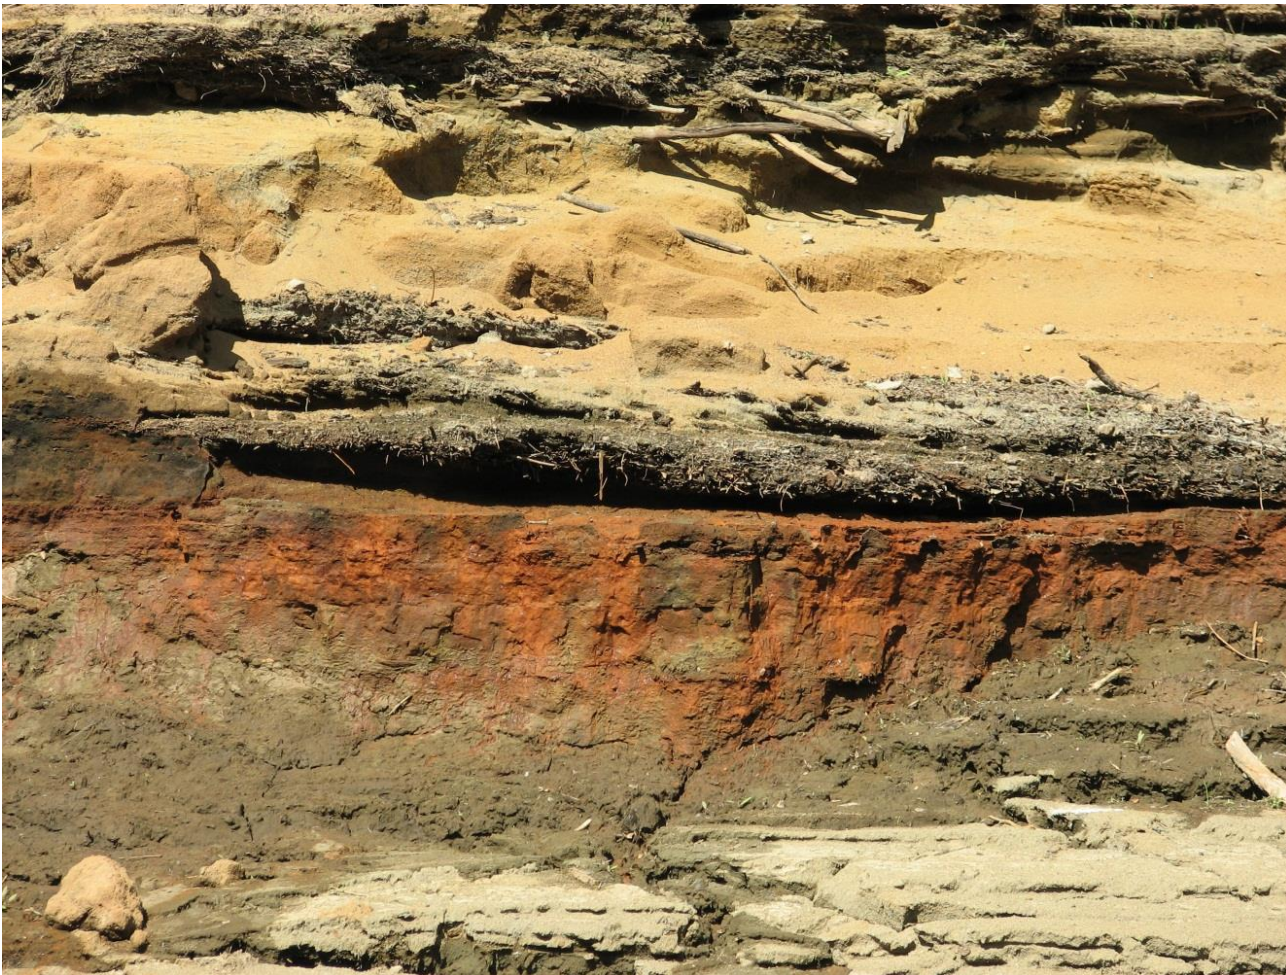
Photo 12 (#7519) - Older reservoir sediments in the Squaw Creek Arm Shasta Lake immediately SW of Madison Gulch 9-26-13. Materials (likely organic) that were in a reducing environment are now oxidizing, and staining underlying sand orange, as Squaw Creek cuts through deposits JdlF

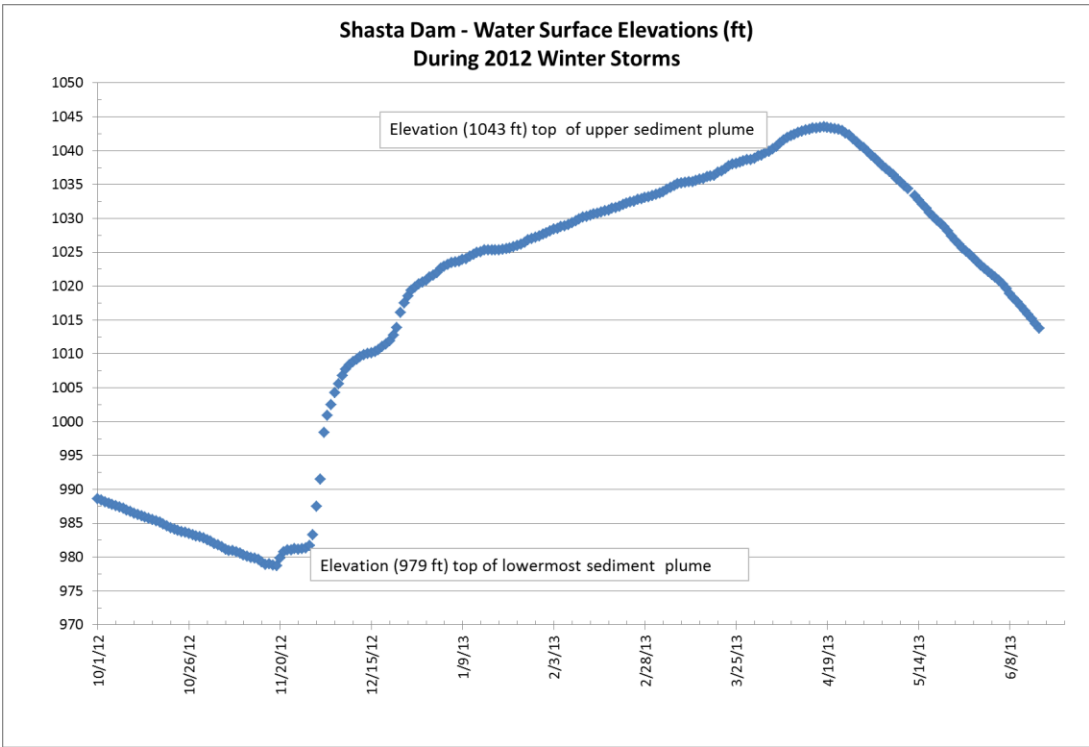
Figure 18- Shasta Lake Water Levels in 2012-2013

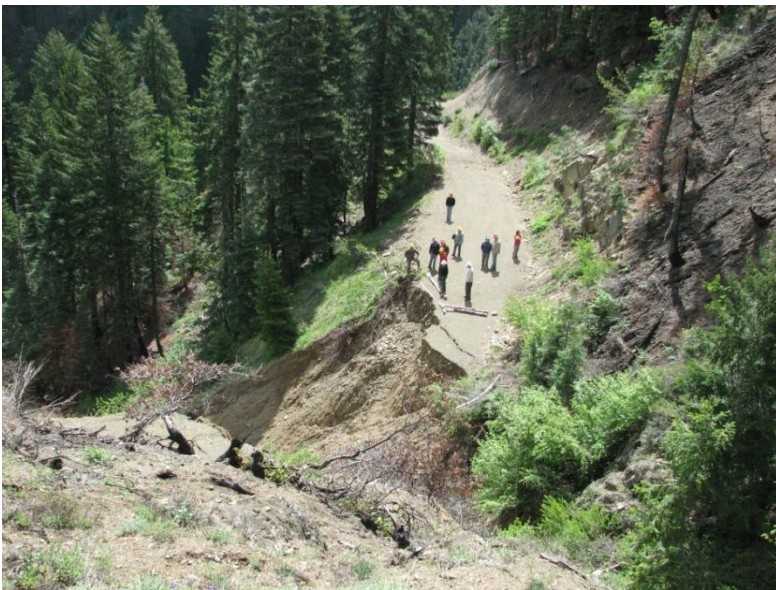
Photo 13 (#2981) - Road Fill Failure Hawkins Creek Watershed 5-17-13 Jdlf

The roads in the Bagley area are all maintenance level 1 and 2. Due to the work done by Sierra Pacific Industries and BAER work accomplished in 2013, most of the roads are at or above recommended condition requirements for level 1 and 2 roads. The main recommendation for these roads would be to keep up with general maintenance, especially to drainage structures. Major road/channel crossing should have critical dips or low water crossings installed.

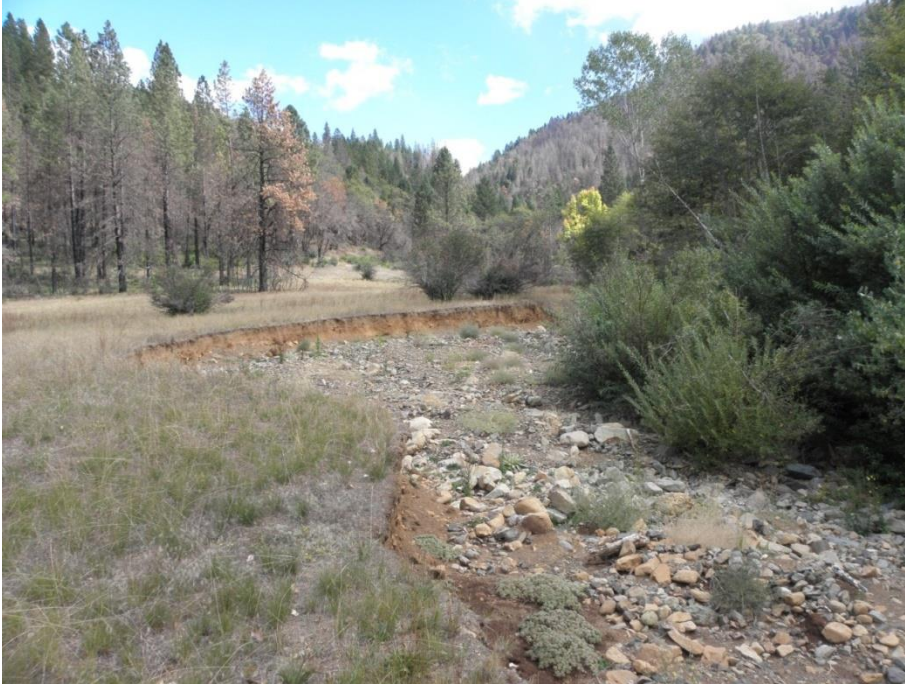
Photo 15 - Modin Creek North Bank Erosion 9-25-2013

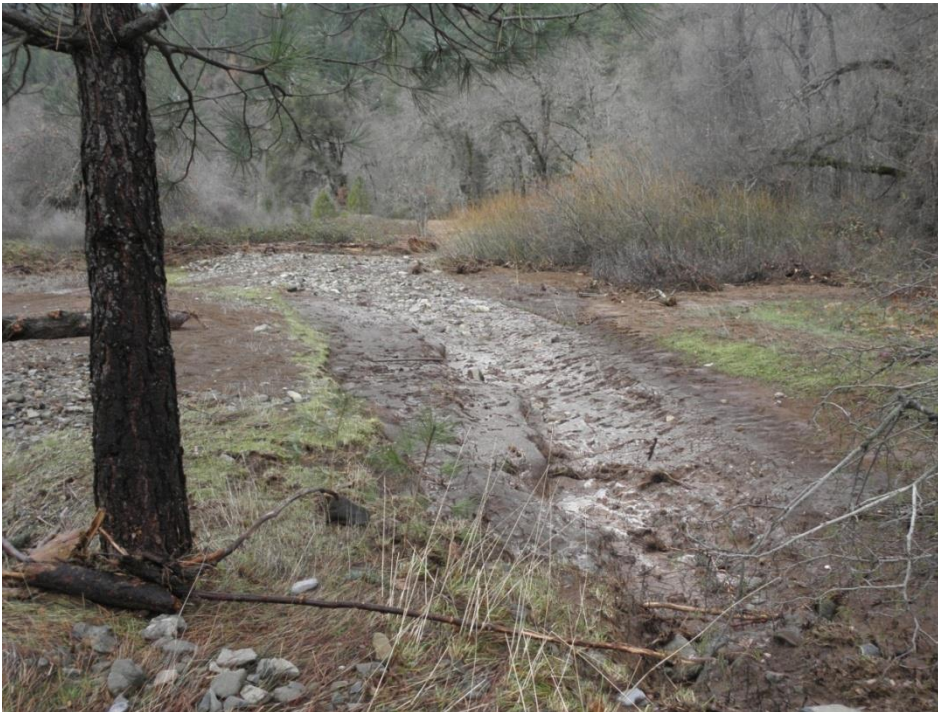
Photo 16 - Wheeler Ranch Road Wash-out 12-14-2012
