THREE MEADOWS RESTORATION

EXISTING CONDITIONS ASSESSMENT AND RESTORATION ALTERNATIVES - DRAFT

Amanda Watson, Amador Resource Conservation District

January 14, 2019

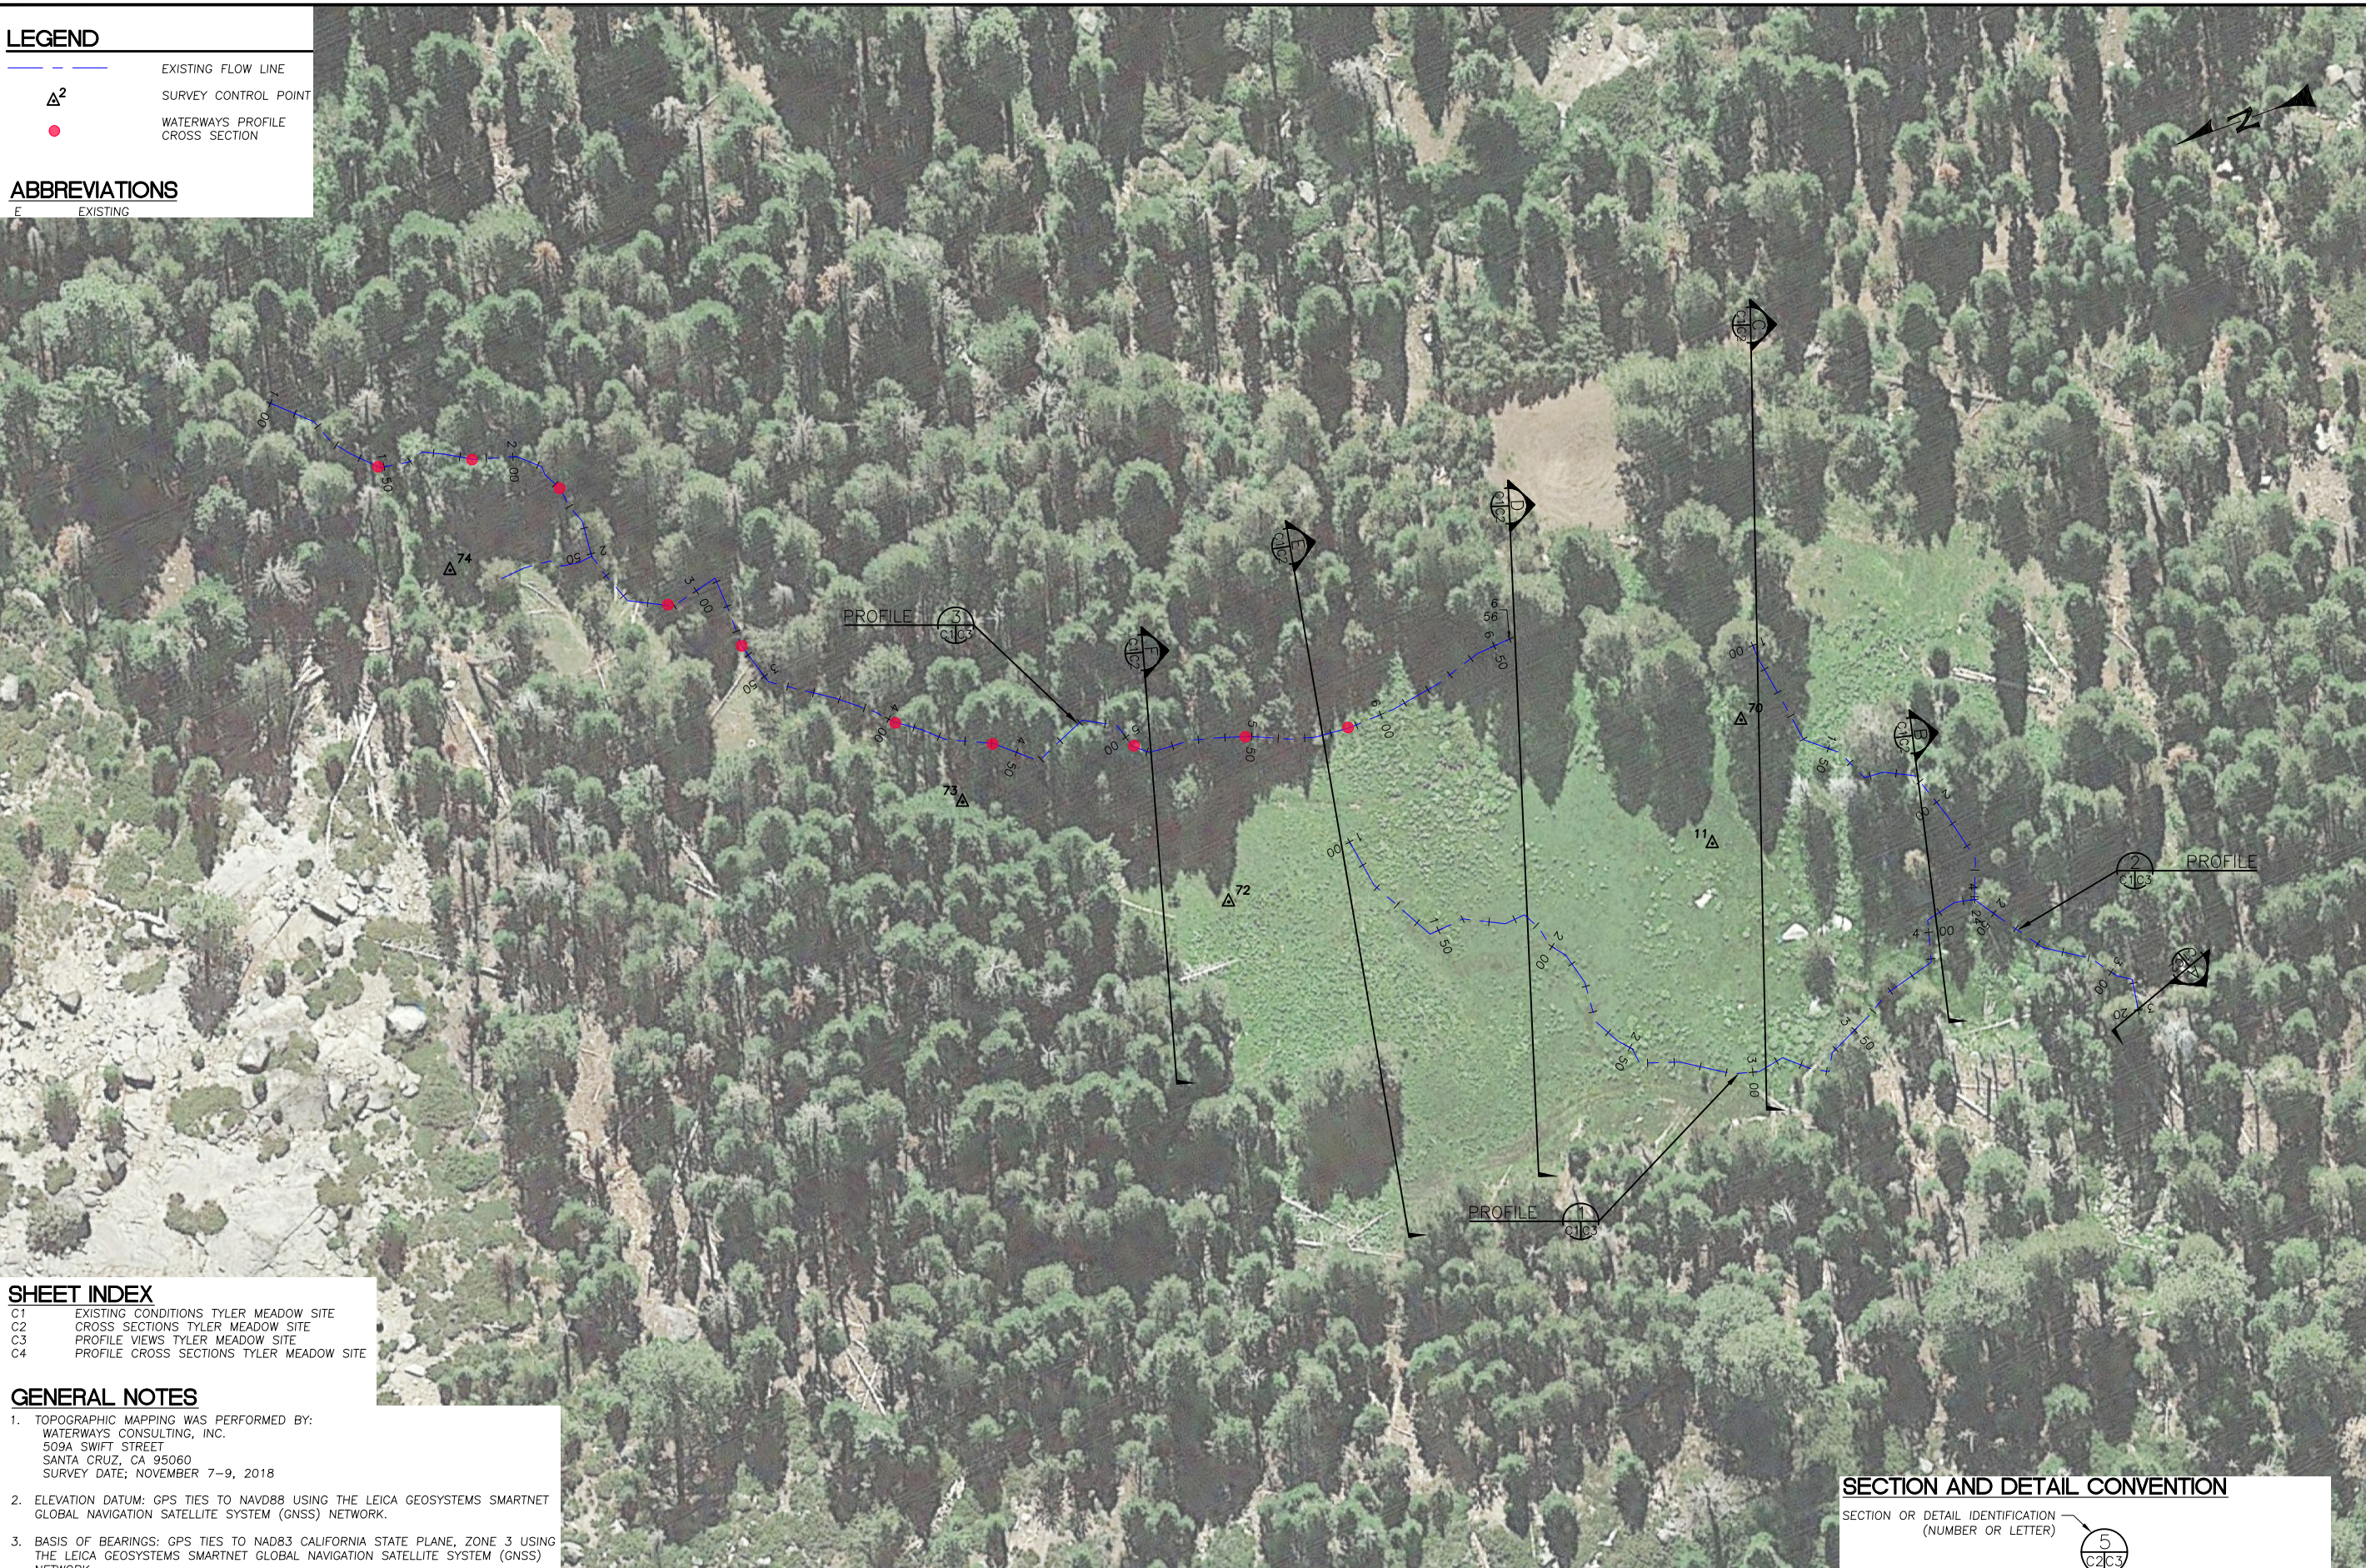
C1 1 OF 4

A meadow assessment protocol utilized at Tyler Meadow by Gwen Starrett and Pat McGreevy in 2017 to resulted in scores of 2 and 4, based on the function being assessed (Table 6). The scoring, which was confirmed by our assessment, suggests that the primary impacts at the site relate to heavy grazing impacts on the meadow itself and the instability of the primary channel that discharges to the meadow. This channel, mapped as Profile 3 during the existing conditions survey (see Appendix C), is moderately incised and appears to be widening. Locally, downed wood has provided some grade control but in many cases the channel has eroded around the wood, resulting in limited benefits. A score of 2 for the Encroachment category of the assessment was due to the fact that OHV's are accessing the meadow and causing some localized impacts.

Log grade control structures at Tyler Meadow would be similar in design to what is being proposed for High Onion. The difference is the fact that the channel dimensions and the level of incision at Tyler are significantly larger so it is likely that heavy equipment would be needed to construct the log weirs at Tyler. Sheet C1 in Appendix C provides locations (red dots) where our field-based assessment identified potential structure locations based on local site conditions. A total of 10 structures have been proposed with a spacing of approximately 50 feet per structure. It is anticipated that all of the logs could be salvaged from the adjacent forest. Furthermore, a flat, tree-free area follows the entire alignment of the channel within the forested area, providing good access from heavy equipment. To avoid impacts to the meadow, an access path could be created from the road. Trees removed to facilitate the access could be used in the structures.

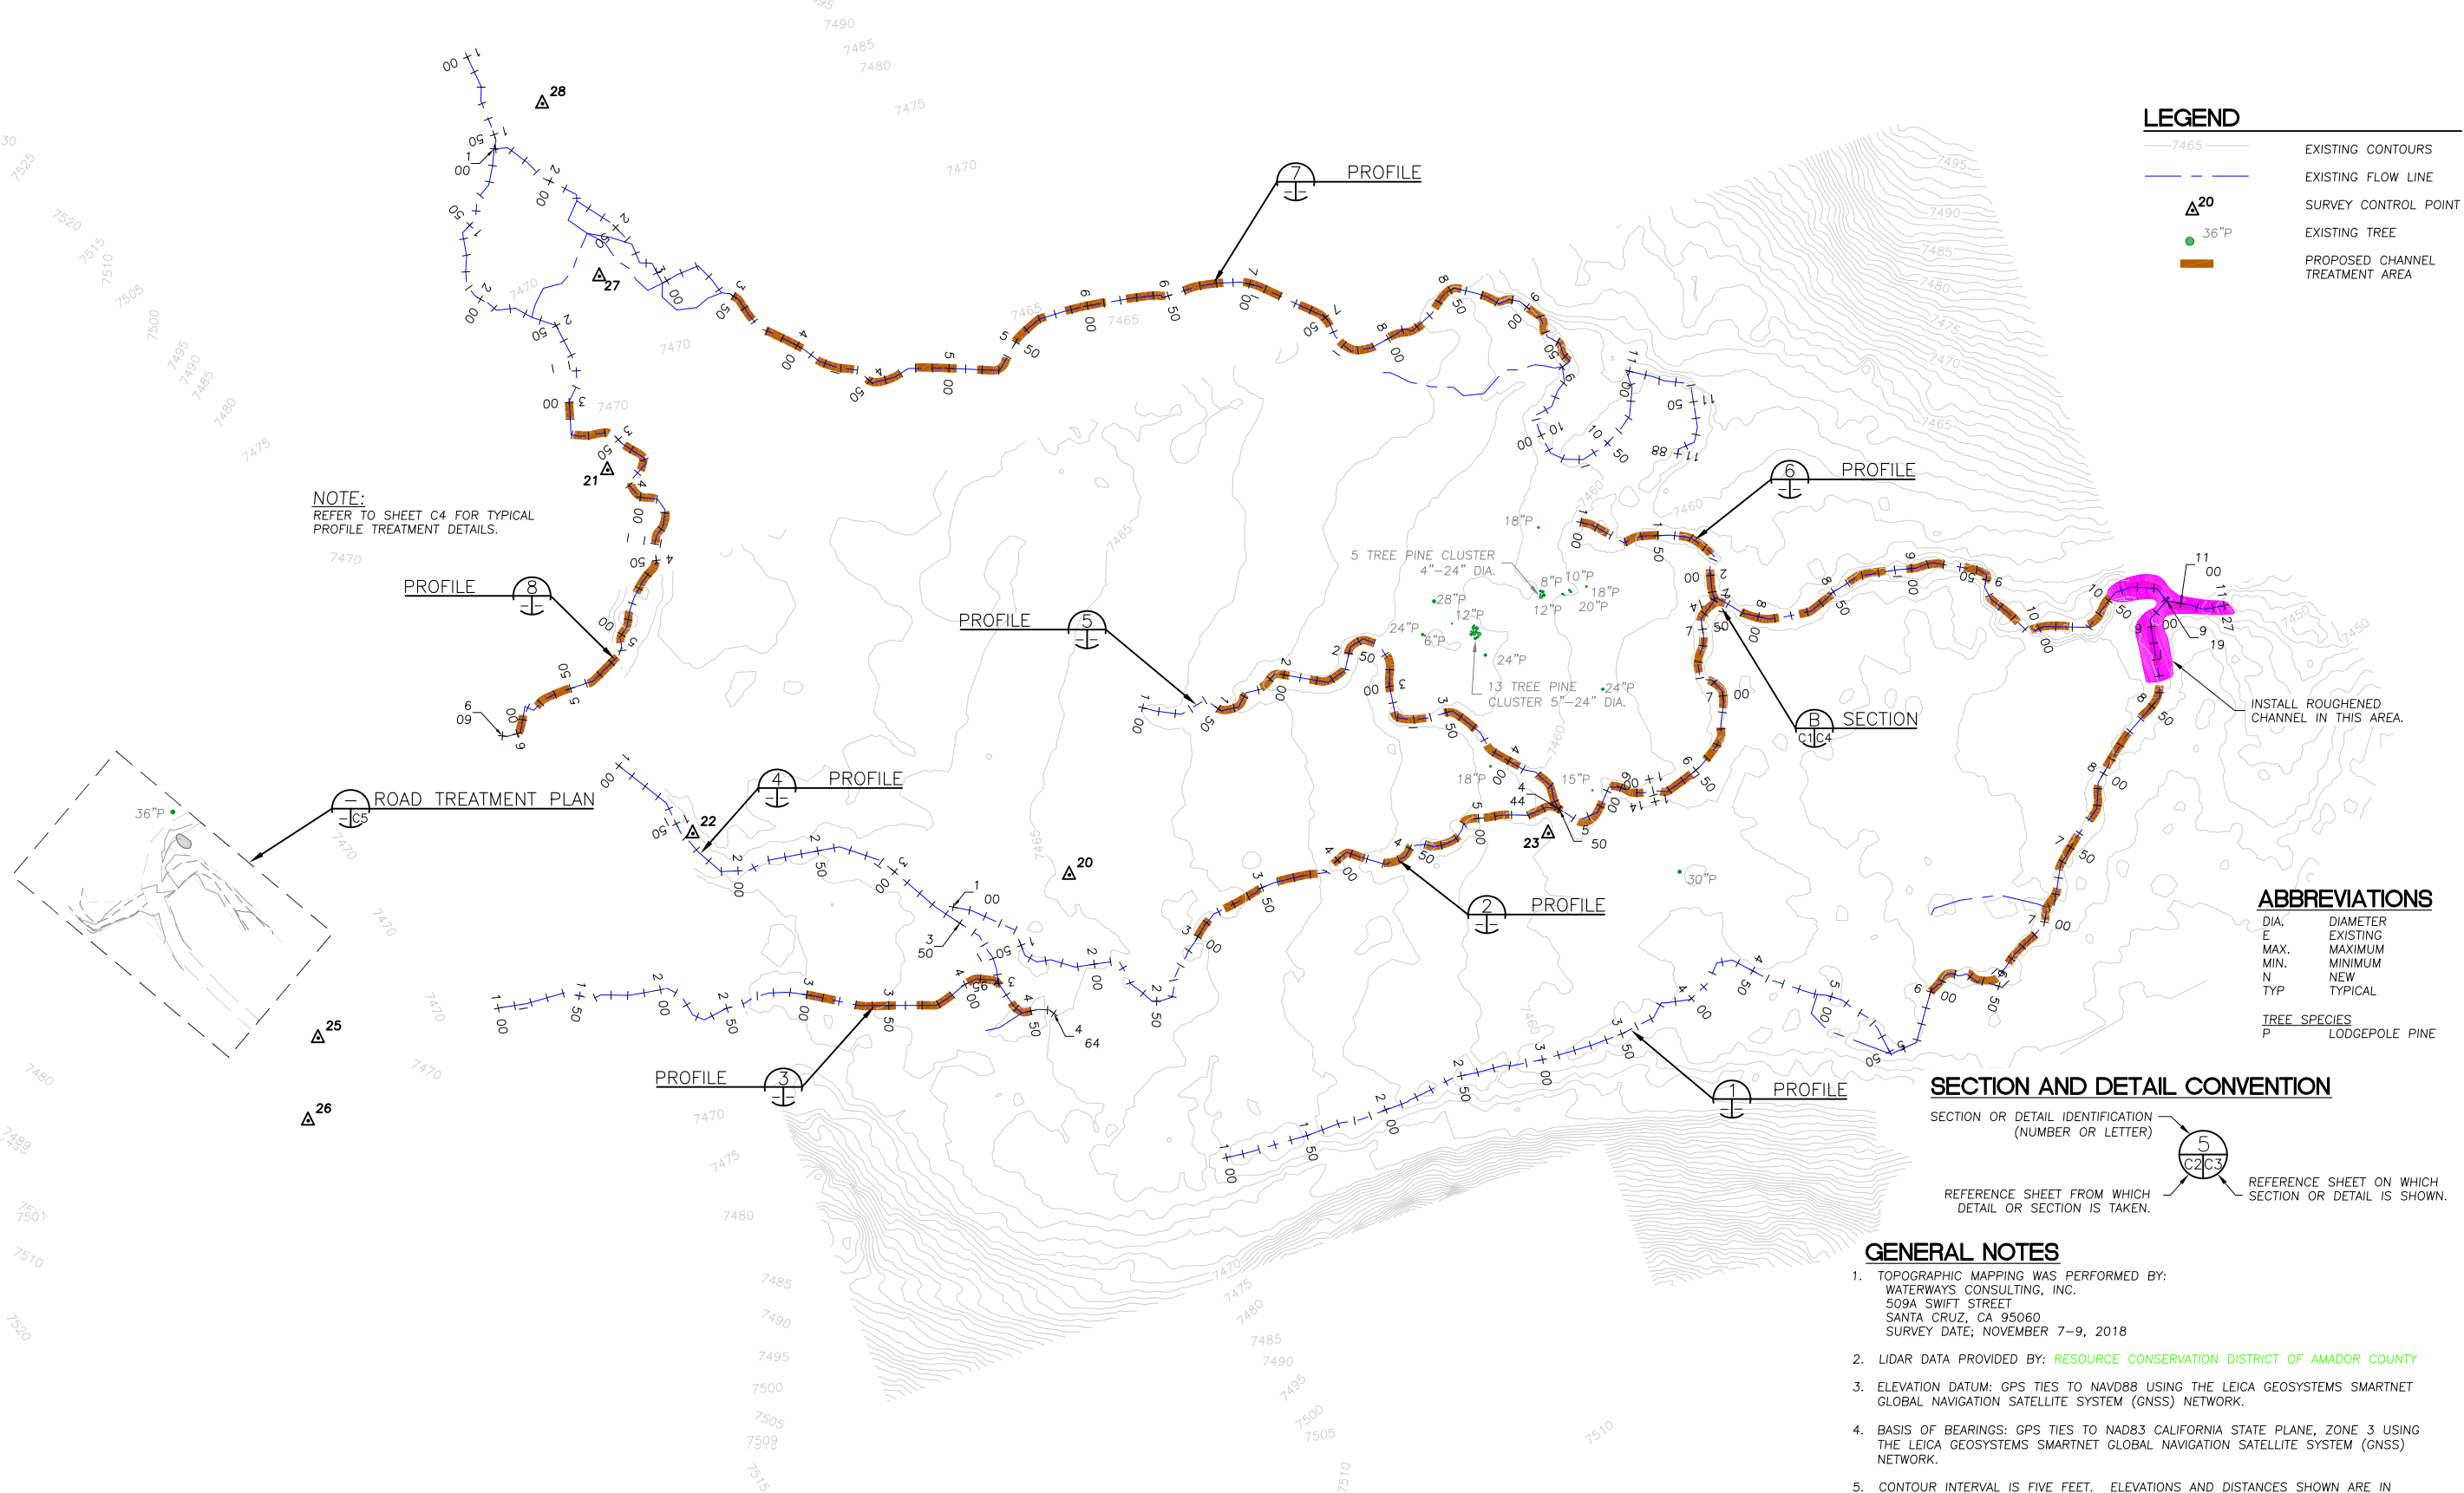
UPPER UNION SITE CONCEPT ALTERNATIVE #2
SCALE: 1" = 50'

- Alternative 2:** Alternative 2 represents the Stage 0 restoration condition. To restore the meadow to its historic condition all of the significant, continuous channels would be filled to a depth equal to the adjacent meadow. Periodically, higher berms in the filled channels would be constructed to ensure that the filled channel is not captured and reincised. Figure 9 provides a preliminary representation of where channels will be filled. This graphic is based on the REM map of Upper Onion Meadow that was discussed previously (Figure 5). To ensure that a headcut does not originate from downstream and reincise the meadow, this alternative will also incorporate a roughened channel at the moraine. Preliminary estimates suggest that a total of 2,200 cubic yards of fill would be required for Alternative 2 in addition to approximately 115 cubic yards of imported material for the roughened channel at the downstream end.
