**FIGURE 4
THREE MEADOWS
RESTORATION PROJECT
TYLER MEADOW
PLAN VIEW**

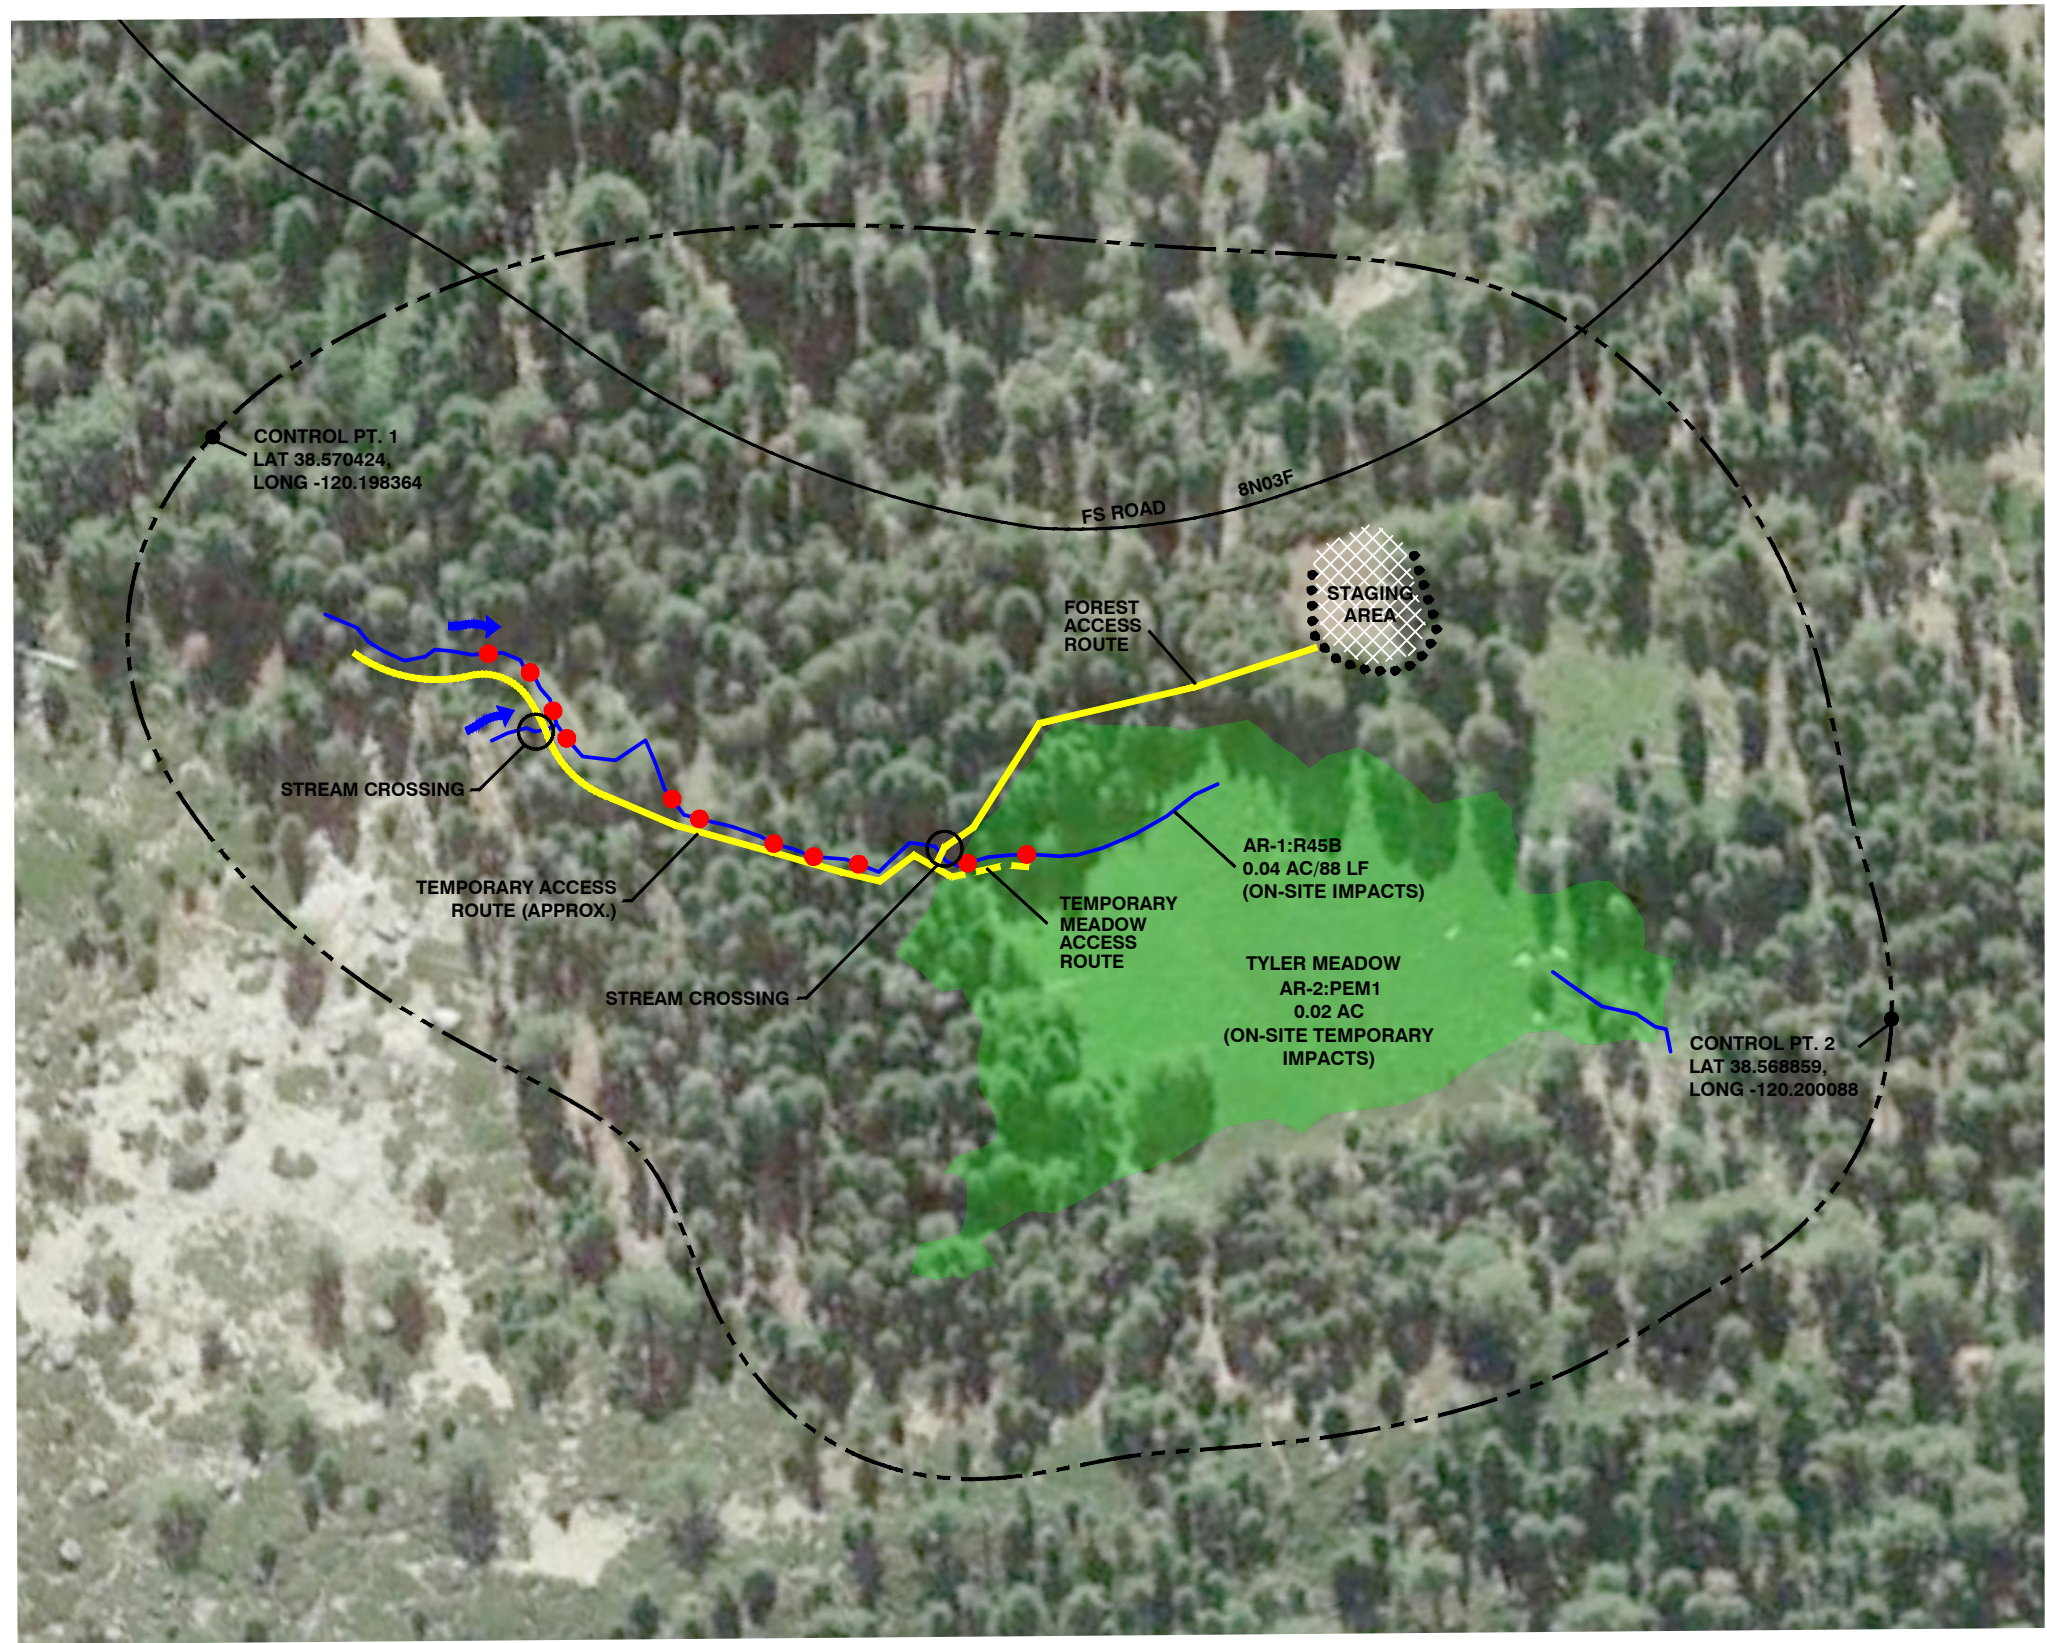
- KEY:**
- LOG WEIR LOCATION
 - SURVEY BOUNDARY (10.3 AC.)
 - ➔ DIRECTION OF FLOW
 - INTERMITTENT STREAM
 - EMERGENT WETLAND (PEM1)
 - BOULDER OR LOG EXCLUSION BARRIER

- NOTES:**
1. The Access Plan shown on the drawings is schematic. Access routes through the forest require tree felling, stump removal, and associated light grading. Access within the meadow shall minimize impacts to meadow vegetation. Contractor shall utilize rubber tracked/tired low ground pressure equipment.

2. Salvage trees felled due to construction and access, as appropriate.
 3. Stage materials within the existing primitive campground. Contain the downslope perimeter of staging or stockpile areas with silt fence.

4. Store, maintain and refuel all equipment and materials in a designated portion of the staging area.
 5. Restore access routes prior to final demobilization. Forest access routes require ripping, seeding, and course wood cover (e.g. logs and slash). Meadow access routes shall be restored to pre-project conditions.

6. Salvage willows at direction of Engineer or USFS representative.
